# Attachment 4: Existing Conditions Photos

**Existing Conditions Photos**

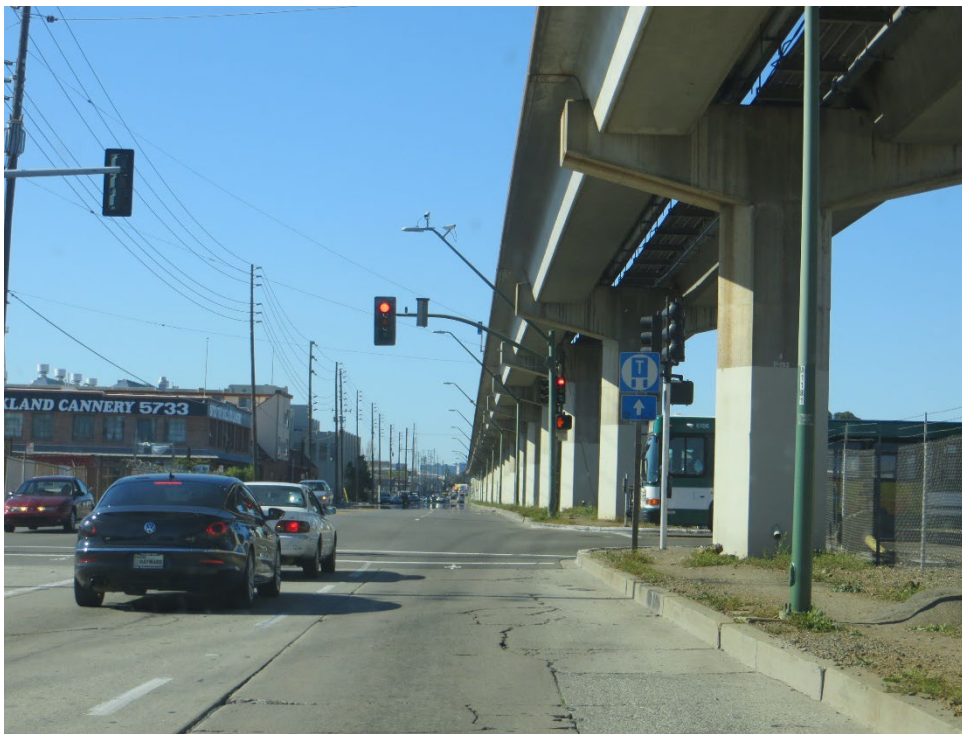
**H-9 |** San Leandro Street at Seminary Avenue in Oakland: There is a lack of pedestrian and bicycle facilities for long stretches of San Leandro Street, and no protected bicycle facilities within the corridor, except the constructed Segment 7A multi-use path from 75<sup>th</sup> to 85<sup>th</sup> Avenues

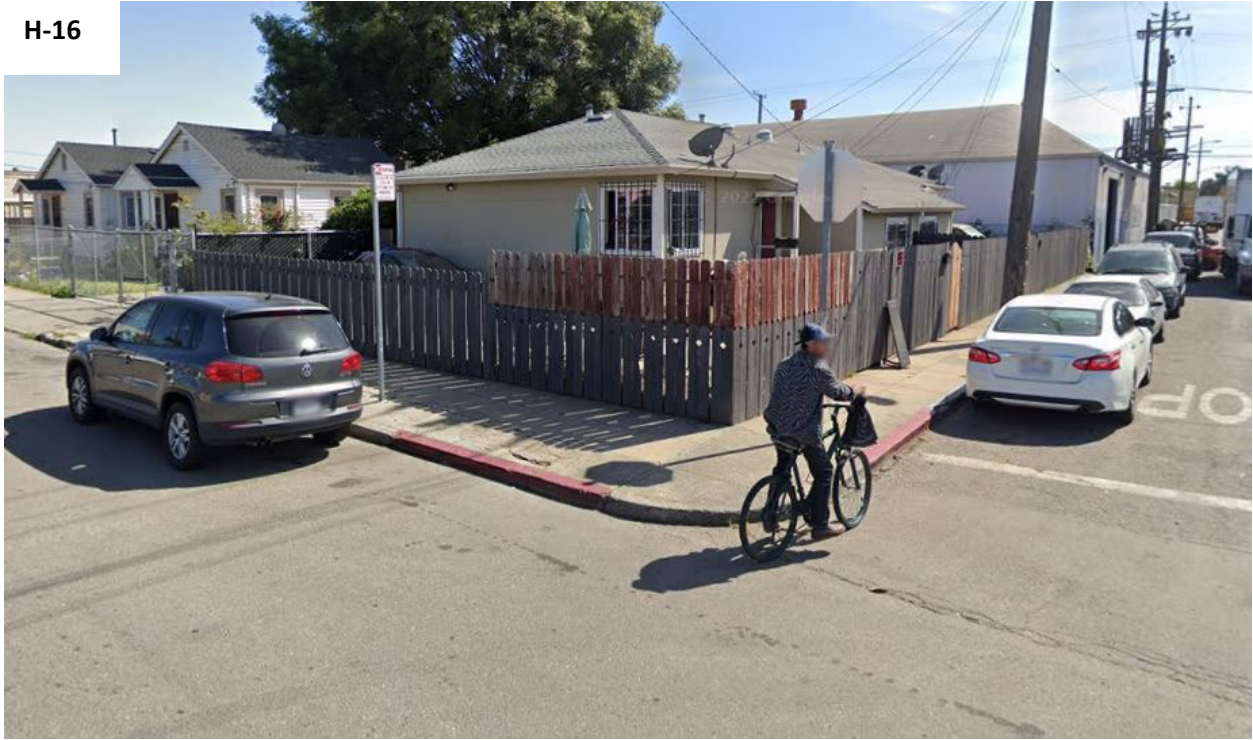
H-16

H-16-17 | Pippin Street in Oakland: Several intersections have not curb ramps

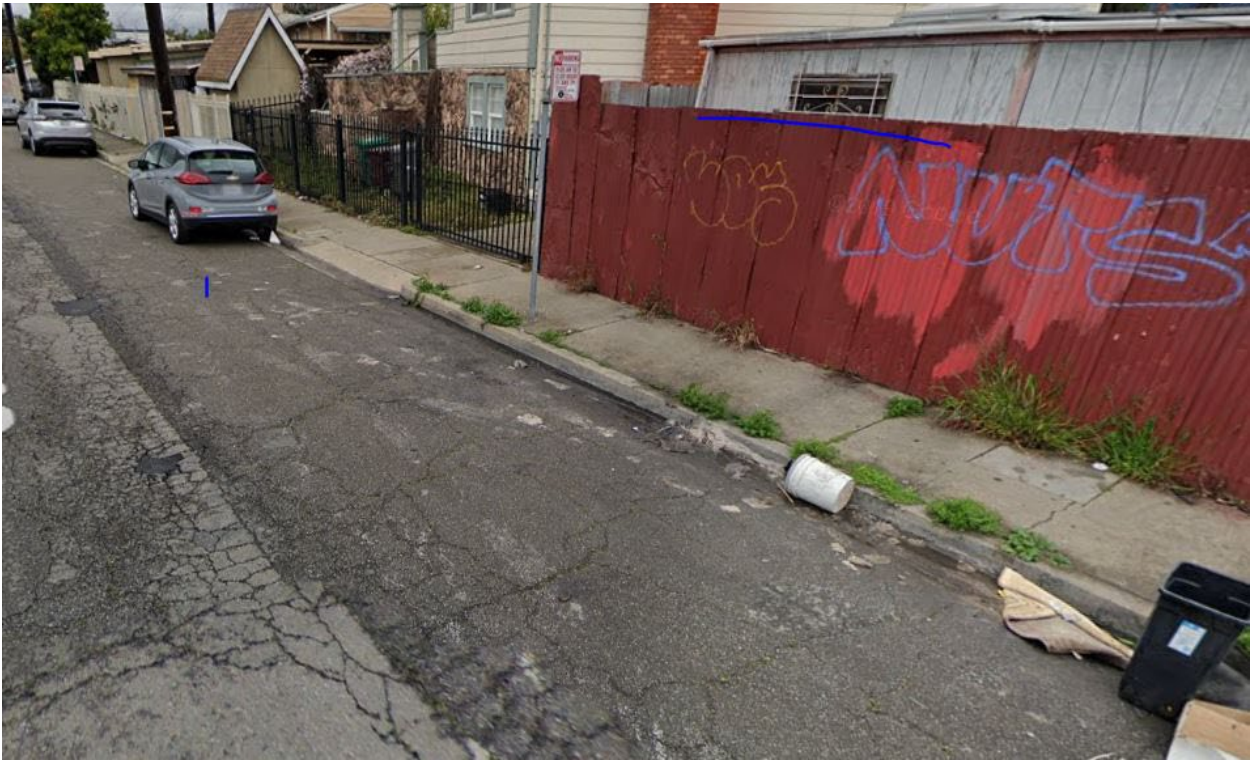
**H-19** | San Leandro Street at Blenheim Street in Oakland: Pedestrians and cyclists must contend with narrow sidewalks and poor pavement conditions

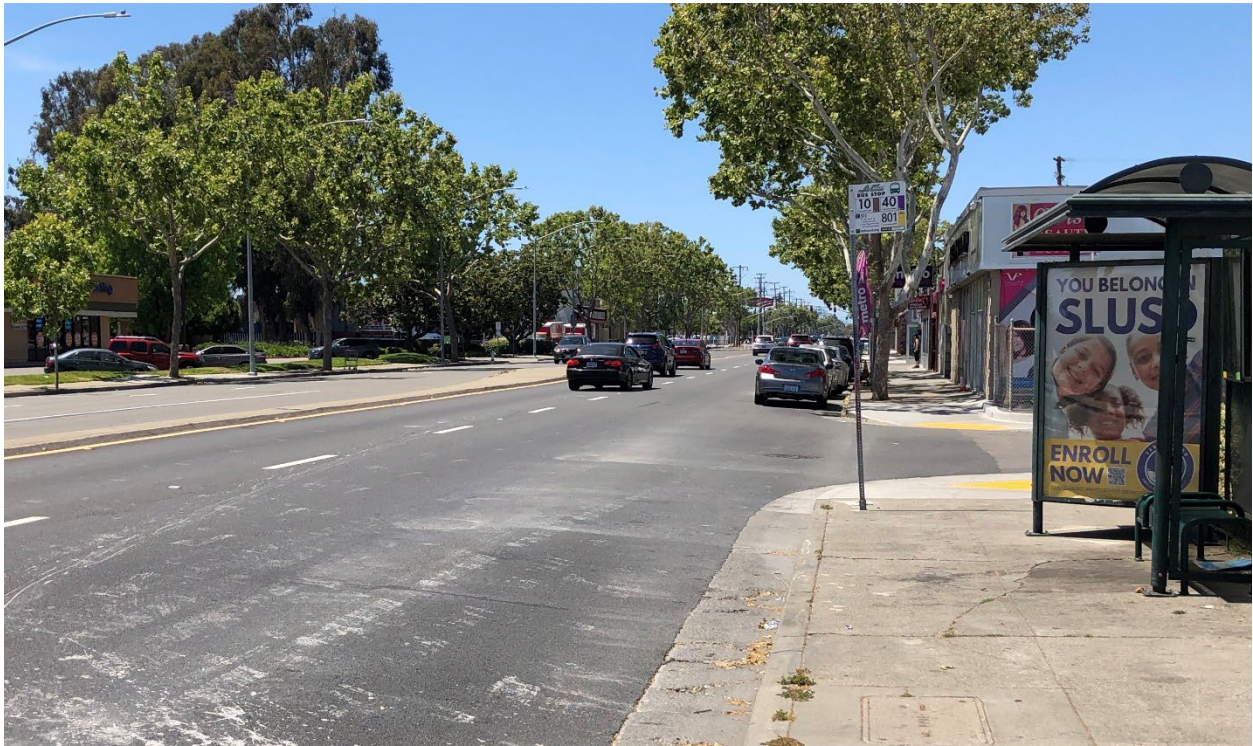
**H-24** | E14<sup>th</sup> Street in San Leandro: There is a lack of crossing opportunities along East 14th, which is in the heart of a commercial district: there are locations where pedestrians must walk up to a quarter mile out of their way to get to a marked crosswalk

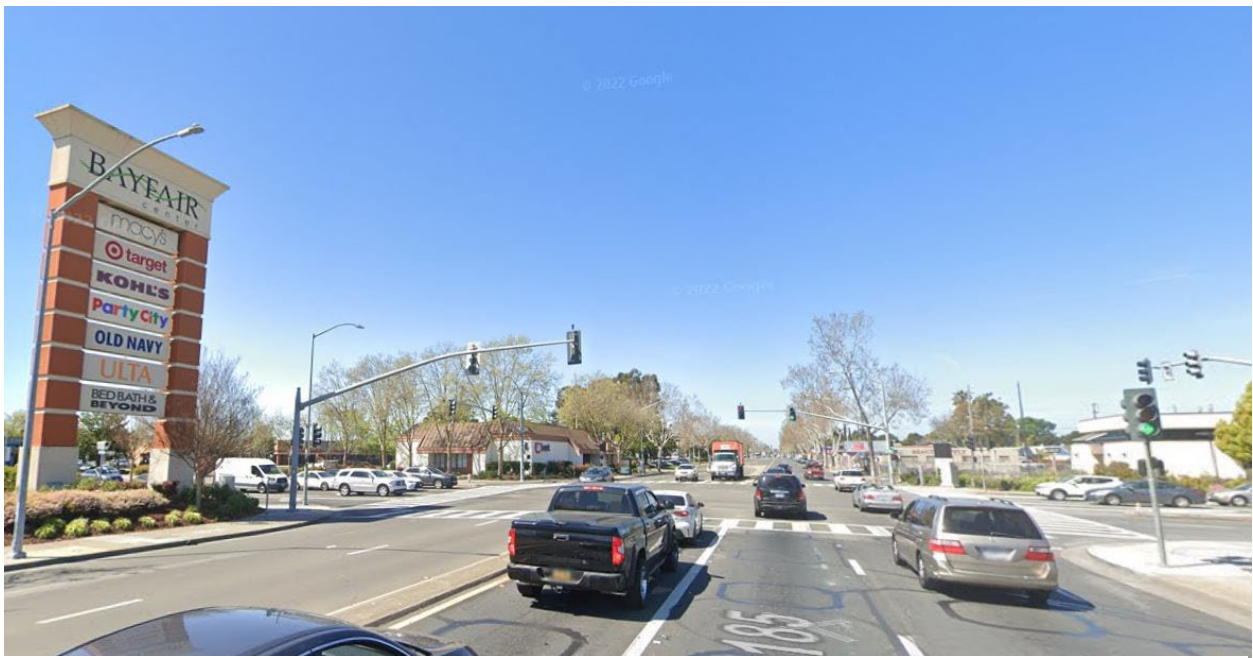
**H-25** | E14<sup>th</sup> Street at Fairmont Street in San Leandro: There are no bike protected intersections within the corridor. Safety would be improved at busy intersections like E14<sup>th</sup> and Fairmont Drive
