Memo

Project: Alameda Rail Corridor and Crossings Assessment

Subject: Oakland Rail Corridors and Crossings

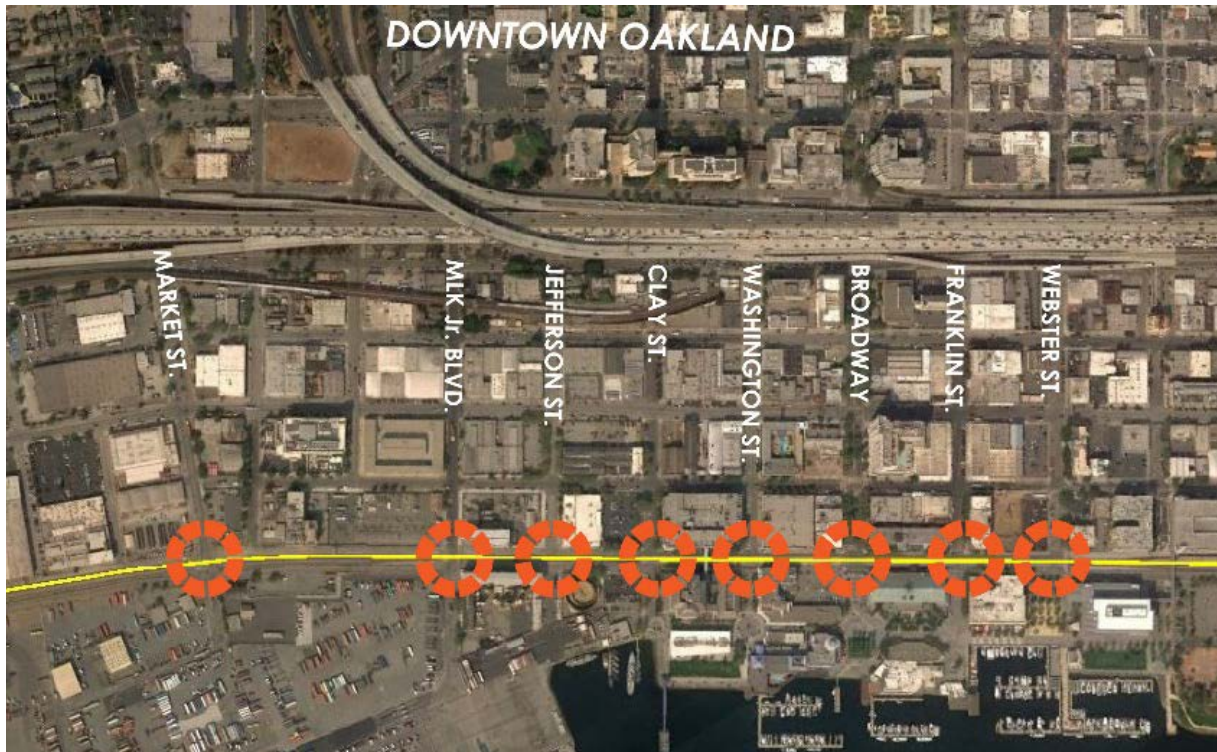
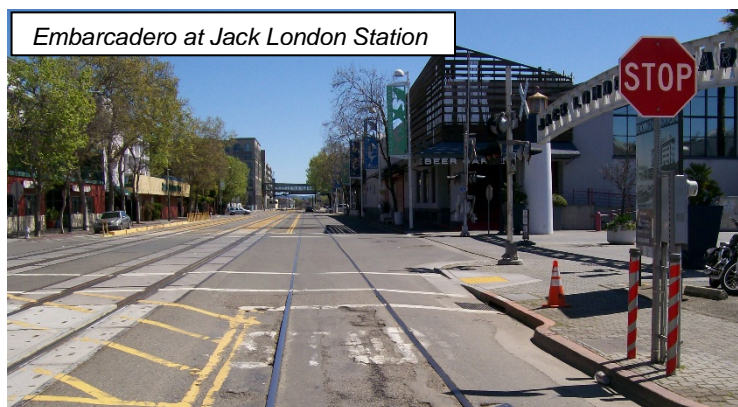
3.2.1 Jack London and Embarcadero Street

The eight crossings between Market Street and Webster Street are spread across 0.6 mile in the Jack London District just south of downtown Oakland. The core set of crossings in this corridor runs from Market Street in the north to Webster Street in the south and includes Broadway (4,500 ADT) which connects Jack London Square to downtown Oakland. Along this stretch, the double-track rail corridor runs in the middle of Embarcadero West with no infrastructure restricting pedestrians from crossing the rail tracks. Train volumes on the corridor include 42 daily passenger trains and an estimated 18 freight trains daily. Combined average daily traffic volume at the corridor crossings is relatively low at 37,700. Vehicle volumes on Embarcadero West are minimal as it is an inconvenient roadway to travel north-south in Jack London District. Due to the wide range of pedestrian and vehicle activity at this corridor, train speeds are limited to 15 mph for freight trains and 20 mph for passenger trains.

This corridor has had significant safety issues with seven crashes over the last ten years resulting in two fatalities. These seven crashes are the third highest of all corridors in Alameda County. Additionally, over the last six years, there were also two trespass collisions that occurred. Moreover, train horns along this corridor create noise that impacts the quality of life at Jack London Square. The residential noise index at this location of 102,334 is 15th highest of all corridors due to the low residential population in the area. However, this underestimates the impact of

noise as the shopping and recreation activities along this corridor are immediately adjacent to the rail tracks and heavily impacted by train noise and their frequency during peak hours. The primary issues for vehicles, pedestrians, and bicyclists along this corridor are safety and noise, and the primary issue for train operations in this corridor is slow train speed that increases trip times for both passenger and freight trains.

A potential solution for this corridor would be grade separation. However, this would involve trenching of the rail line which has an estimated construction cost of over \$250 million and several hundred millions of dollars more in freight mitigation costs during construction⁴. A lower-cost option for the corridor would be comprised of the following improvements:

- Eliminate eastbound travel on Embarcadero and convert one lane of roadway into a pedestrian esplanade
- Retain the westbound travel lane for one-way traffic; eastbound traffic would need to use 2nd Street or 3rd Street which are both lightly traveled roads
- Reopen Jefferson Street to replace access to Howard Terminal lost by converting Embarcadero to one way street; traffic analysis is required to determine if additional access is needed to Howard Terminal

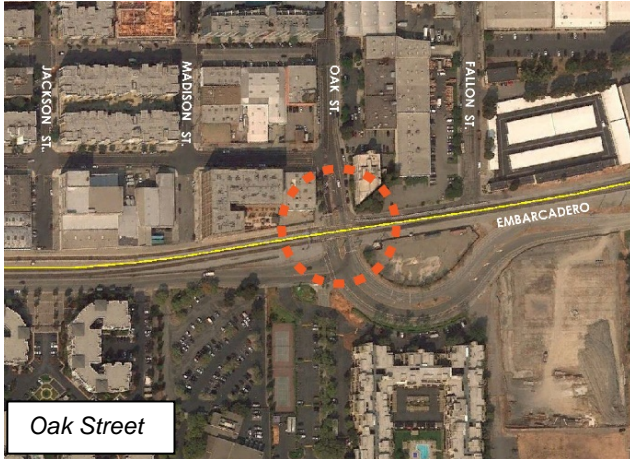
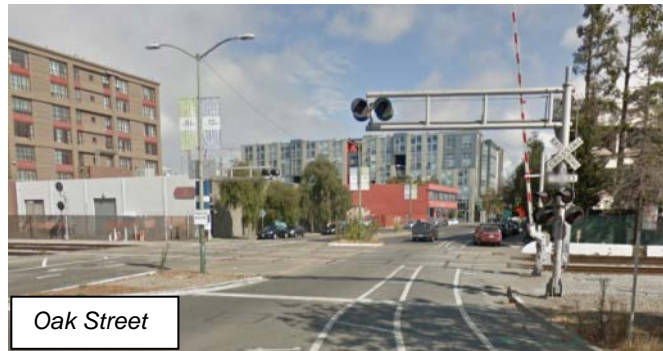
3.2.2 Oak Street

The Tier 1 Oak Street crossing is a two-lane roadway with medians, bike lanes, and shoulders. The roadway crosses the three tracks at a 90-degree angle, and sidewalk extends across the tracks on the north side of the roadway. There is no paved sidewalk to the southwest of the crossing. Warning devices consist of two-quadrant flashing lights with gates and cantilevered arms with flashing lights located on the outside of lanes. The crossing panels and pavement markings are in good condition. There appears to be adequate street lighting.

Potential deficiencies noted in the site visit include:

Recommended near-term safety enhancements include:

- Construct curb, gutter, and sidewalk through crossing on south side of crossing
- Place fences on west side of railroad right-of-way
- Install partial 200-foot-long fence (100 feet on each side of the street) and maintenance access gates to each quadrant to deter trespassing
- Close the Fallon Street intersection so pedestrians have a refuge area in the southeast quadrant
- Install new pavement markings and striping at crossing

Four-quadrant warning devices would likely be required as a supplemental safety measure should the City desire to apply for Quiet Zone that includes this crossing. Extending the median to the west was considered, but this would disrupt through traffic on Embarcadero. The portion of Fallon Street parallel to the tracks will be required to be closed as a part of this improvement because its location is in conflict with the location of a new warning device in the southeast quadrant.

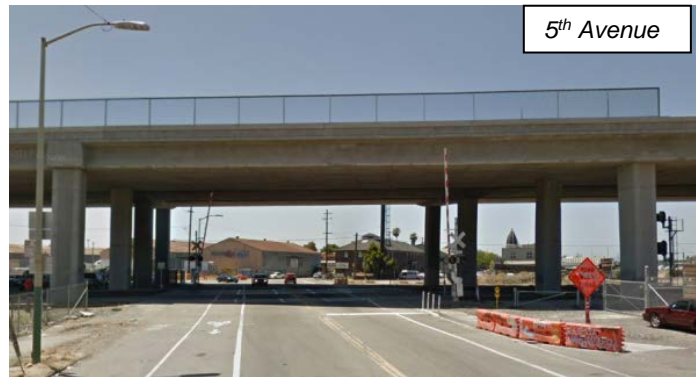
The Tier 1 5th Avenue crossing is a two-lane roadway with bike lanes and shoulders. The roadway crosses the three tracks at a 90-degree angle. There are no sidewalks through the crossing. Warning devices consist of two-quadrant flashing lights with gates located on the outside lanes. The crossing panels are in good condition. There appears to be adequate street lighting.

Potential deficiencies noted in the site visit include:

- Worn railroad pavement markings
- Eastbound warning device not protected from the roadway
- No curbs, gutters, or sidewalks through the crossing
- Northwest quadrant and railroad right-of-way not fenced

Recommended near-term safety enhancements include:

- Construct a 100-foot-long raised median on both sides of crossing; this may require the relocation of the driveway in the northeast quadrant
- Repaint worn railroad pavement markings
- Construct curb, gutter, and sidewalk through crossing on each side of the road; new curbs will help protect the warning devices
- Install partial 200-foot-long fence (100 feet on each side of the street) and maintenance access gates to each quadrant to deter trespassing

- Install “No Trespassing” signs
- Install new pavement markings and striping at crossing

The existing two-quadrant gates with the raised median and restricted access are sufficient supplemental safety measures should the City decide to apply for a Quiet Zone that includes this crossing. Four-quadrant gates are not required since the combination of gates and median is an approved supplemental safety measure that prevents vehicles from driving around the gates.

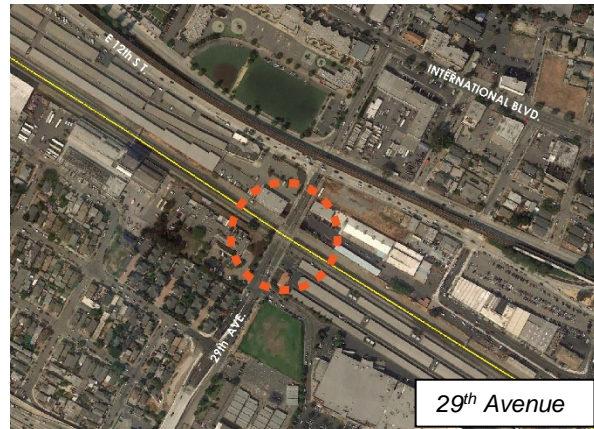
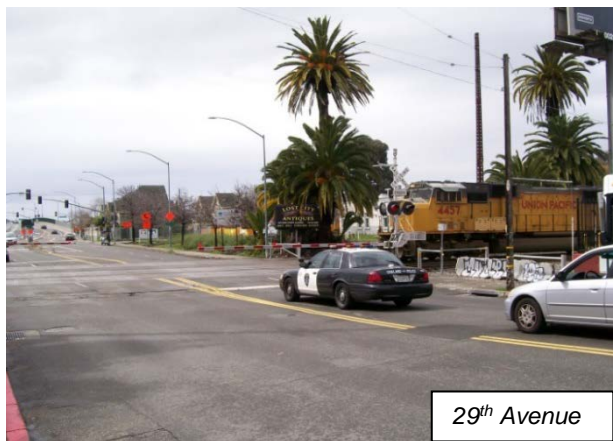
The Tier 1 29th Avenue crossing is a four-lane roadway. The roadway crosses the three tracks at an 86-degree skewed angle. Sidewalks extend across the tracks on both sides of the roadway. Warning devices consist of two-quadrant flashing lights with gates located on the outside lanes. The crossing panels and pavement markings are in good condition and there appears to be adequate street lighting. The Epic

Potential deficiencies noted in the site visit include:

- Deteriorated asphaltic concrete (AC) pavement in the vicinity of the crossing
- Defaced railroad crossing warning signs
- Sidewalks are not delineated within railroad right-of-way
- Substandard sidewalk clearance when gate arms are down; no exit path behind gates
- Warning devices not protected from roadway

Recommended near-term safety enhancements include:

- Remove homeless encampment in the southeast quadrant of railroad right-of-way
- Replace defaced railroad crossing warning signs; install “Do not stop on tracks” (R8-8) signs in both directions
- Add dynamic envelope pavement markings near tracks
- Repair AC pavement
- Construct curb, gutter, and sidewalk through crossing
- Construct raised concrete median extending 100 feet from the crossing to the east and connecting to the existing median to the west
- Due to the proximity of multiple schools, install pedestrian warning devices
- Install partial 200-foot-long fence (100 feet on each side of the street) and maintenance access gates to each quadrant to deter trespassing
- Install new pavement markings and striping at crossing
- Consider a queue cutter intermediate signal due to the proximity of this crossing to the intersections on each side of the crossing

The existing two-quadrant gates with the raised median and restricted access are sufficient supplemental safety measures should the City decide to apply for a Quiet Zone that includes this crossing. Four-quadrant gates are not required since the combination of gates and median is an approved supplemental safety measure that prevents vehicles from driving around the gates.

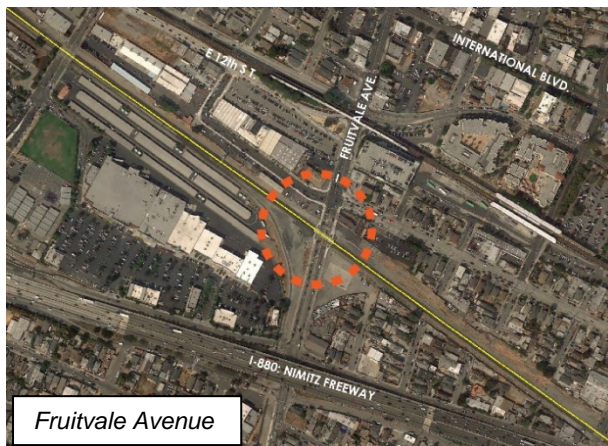
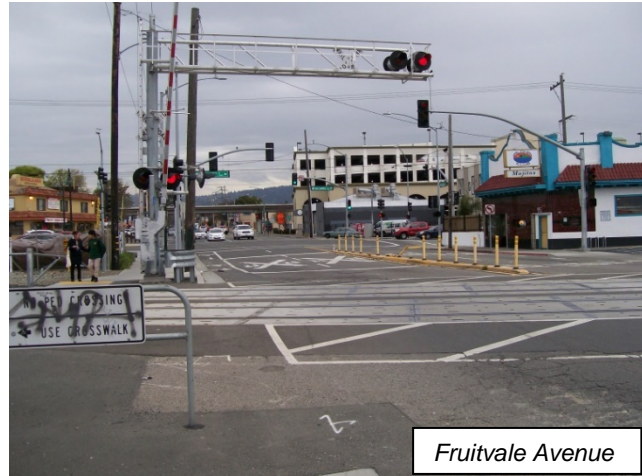
4.2.2 Fruitvale Avenue

The Tier 1 Fruitvale Avenue is a four-lane street that crosses the two main tracks at 70 degrees. Recently constructed sidewalks, with tactile warning surfaces, extend across the tracks on both side of the roadway. The sidewalks allow for an exit path behind the gates. Warning devices consist of two-quadrant flashing lights with gates and cantilevered arm with flashing lights located on the outside of the road. The sidewalks in the opposing direction of travel have flashing lights (CPUC standard No. 8s). The eastbound direction is signalized in conjunction with 10th/San Leandro Street. The crossing panels and sidewalks are in good condition.

Potential deficiencies noted in the site visit include:

- Damaged channelization devices on median
- Worn pavement markings
- Railroad crossing warning (W10-1) and the westbound “2 tracks” (W48 CA) signs missing in both directions
- “No Trespassing” signs missing or defaced
- Railroad right-of-way in northwest quadrant and along Fruitvale Ave not fenced

Recommended near-term safety enhancements include:

- Replace damaged channelization devices
- Repaint pavement markings and replace missing railroad warning signs
- Install partial 200-foot-long fence (100 feet on each side of the street) and maintenance access gates to each quadrant to deter trespassing
- Install new pavement markings and striping at crossing

The existing two-quadrant gates with the raised median and restricted access are sufficient supplemental safety measures should the City

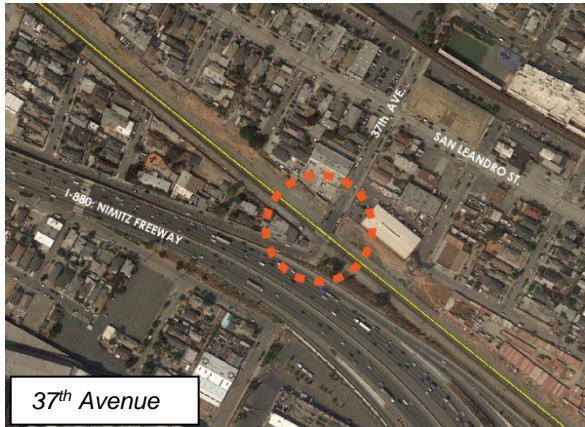
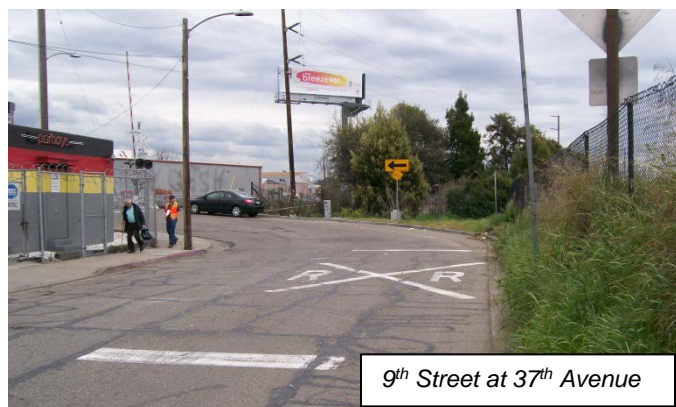
4.2.3 37th Avenue

The Tier 1 37th Avenue is a two-lane street that crosses the two main tracks at 81 degrees. A sidewalk extends across the track on the north side of the roadway. Warning devices consist of two-quadrant flashing lights with gates located on the outside of the road. The crossing panels are in good condition. Just west of the crossing, 37th Avenue turns into 9th Street at a sharp curve 55 feet west of the tracks. There appears to be adequate street lighting.

Potential deficiencies noted in the site visit include:

- Very limited sight distances when traveling eastbound due to the sharp curve and parking near the crossing
- No center striping or median
- Worn pavement markings
- Eastbound railroad crossing warning signs missing; westbound “2 tracks” sign (W48 CA) defaced

Recommended near-term safety enhancements include:

- Construct 100-foot-long raised median on both sides of crossing
- Construct curb, gutter, and sidewalk through crossing (sidewalk construction to ensure exit path around gate)
- Install new pavement markings and striping at crossing
- Replace missing and defaced signs
- Install “No Parking” signs west of crossing
- Install advanced warning flashing light beacon on same post as circular RxR sign (W10-1) for the eastbound direction
- Repair holes in the railroad right-of-way fence near crossing
- Install partial 200-foot-long fence (100 feet on each side of the street) and maintenance access gates to each quadrant to deter trespassing
- Install “No Trespassing” signs

The existing two-quadrant gates with the addition of raised median are sufficient supplemental safety measures should the City decide to apply for a Quiet Zone that includes this crossing. Four-quadrant gates are not required since the combination of gates and median is an approved supplemental safety measure that prevents vehicles from driving around the gates.

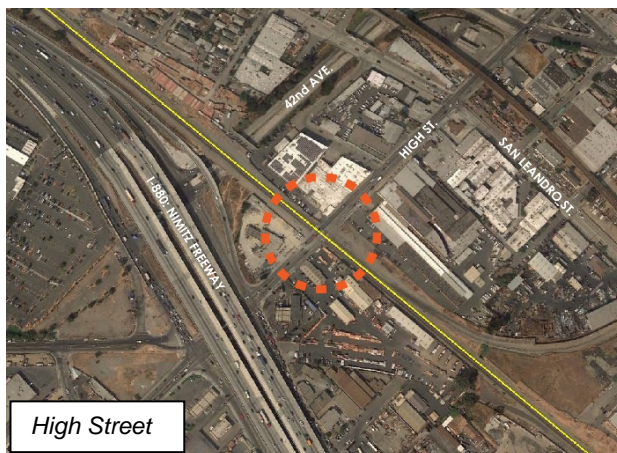
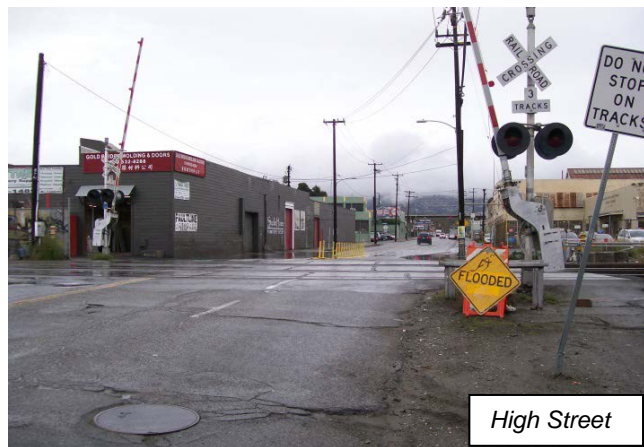
4.2.4 High Street

The Tier 1 High Street crossing is a four-lane roadway located one block (450 feet) south of the 42nd Avenue underpass. Over 43,000 vehicles use this crossing daily. The roadway crosses the three tracks at an 85-degree skewed angle. Sidewalks extend across the track on both sides of the roadway. Warning devices consist of two-quadrant flashing lights with gates located on the outside lanes.

There is a substantial drainage problem on the east side of the street. Flooding in the street appears to immobilize vehicles, which cause traffic to back up through the crossing. The flooding encroaches into both sidewalks and, during these events, the only dry location on the south side is the railroad right-of-way.

Potential deficiencies noted in the site visit include:

- Multiple channelization devices damaged or missing on the east side of the tracks
- Large homeless encampment along railroad right-of-way to the north
- Deteriorated AC pavement
- Broken crossing panel; other panels create an uneven surface
- Nearest street light to the west is 80 feet away and to the east is 50 feet away; additional lighting may be required
- Substandard sidewalk clearance when gate arms are down
- Worn pavement markings
- Missing railroad warning signs

- East gate not protected from traffic; on the south side, an old gate foundation and guardrail are abandoned in place
- Traffic queues across the tracks to access I-880 and the City of Alameda during peak periods

Recommended near-term safety enhancements include:

- Repair broken crossing panel and resurface all panels
- Construct concrete curb, gutter, and sidewalk; curb will provide protection to the gates and the sidewalk will allow passage around gates

- Remove abandoned foundation and guardrail
- Install partial 200-foot-long fence (100 feet on each side of the street) and maintenance access gates to each quadrant to deter trespassing

- Install “No Trespassing” signs
- Install a queue cutter intermediate signal; there is only about 300 feet of storage space between the crossing and the intersection with Coliseum Way and vehicles were observed stopped on the tracks

- Install new pavement markings and striping at crossing

Four-quadrant warning devices would likely be required as a supplemental safety measure should the City desire to apply for Quiet Zone that includes this crossing. The roadway does not appear to be wide enough to construct a raised median and the existing channelization devices to the east are damaged. The lumberyard driveway to the west also appears to have a large number of left-turn truck movements leaving the facility. With only channelization devices, trucks would be tempted to drive over them.

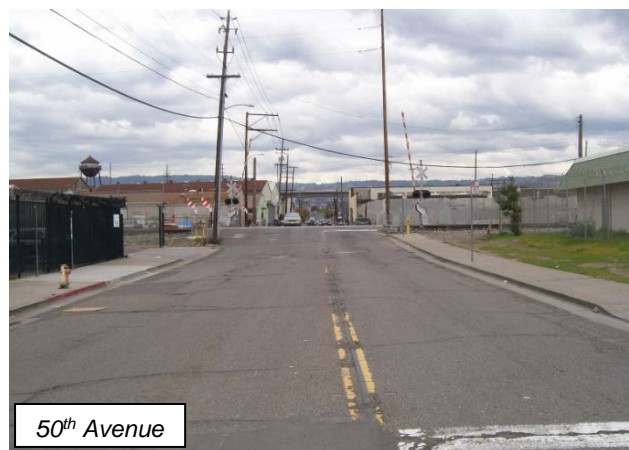
The Tier 1 50th Avenue is a two-lane street that crosses the two main tracks at 90 degrees. There are sidewalks on the west side of the crossing and they terminate near the crossing. The east side does not have sidewalks. Warning devices consist of two-quadrant flashing lights with gates located on the outside of the road. The crossing panels are in good condition.

Potential deficiencies noted in the site visit include:

- Old signal foundations and guardrails abandoned in sidewalk
- Worn pavement markings and stop lines
- Railroad crossing warning (W10-1) and “2 tracks” (W48 CA) signs missing in both directions
- “No Trespassing” signs missing or defaced
- No fence or maintenance gates in all quadrants to restrict access to the right-of-way
- Roadway approaches to the crossing panels are humped causing vehicles to scrape the pavement as they cross the tracks

Recommended near-term safety enhancements include:

- Remove old signal foundations and guardrails
- Construct curb, gutter, and sidewalk through crossing; curb will provide the gate protection and the new sidewalk will allow an exit path behind the gates when they are down
- Pave street to smooth out the profile to eliminate scraping at the crossing
- Repaint pavement markings and stop lines
- Replace missing railroad warning signs
- Install partial 200-foot-long fence (100 feet on each side of the street) and maintenance access gates to each quadrant to deter trespassing
- Install “No Trespassing” signs in all quadrants
- Install four-quadrant warning devices
- Install new pavement markings and striping at crossing

Four-quadrant gates would likely be required as a supplemental safety measure should the City decide to apply for a Quiet Zone that includes this crossing. Constructing a median on the west side of the crossing appears to be problematic with a driveway 25 feet from the crossing unless the driveway could be closed. If the driveway could be closed, then two-quadrant gates and raised median would be acceptable supplemental safety measures.

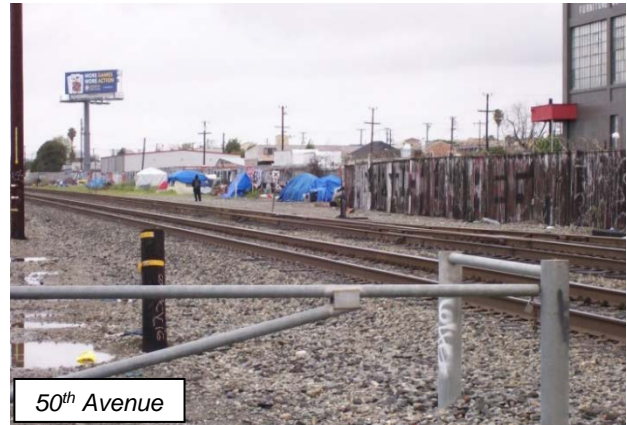
Grade Separation “Initial Scan”: As a Tier 1 crossing, HDR assessed the design options for a grade separation at 50th Avenue. Based on low traffic volumes, a grade separation at 50th Avenue is a low priority and should be considered for closure possibly as part of the High Street grade separation. If 50th Avenue is grade separated, a 70-foot-long roadway underpass (70-foot-long railroad structure over the roadway) would likely be required at this location.

Based on experience with similar sites, the preferred railroad superstructure would likely consist of a two-span 35-foot-long rolled steel beam deck bridge with a steel ballast pan to bring the superstructure depth down to 5 feet from top of rail. For foundations, the center pier and abutments would need to be supported by large diameter CIDH or CISS piles, concrete columns, and precast concrete caps. The roadway profile would need to be depressed approximately 20 feet below the surrounding ground. A pump station would be required to pump stormwater out of the roadway portion of the underpass. The roadway profile conform points are approximately 650 feet on either side of the crossing.

Access to the properties immediately adjacent to the tracks and road may need to be reconfigured or the property may need to be acquired. Intersections with San Leandro Street and Coliseum Way would need to be adjusted since 50th Avenue would not have been able to conform back to existing elevations. This grade separation would need to be studied further to ensure it is feasible to conform by the time the street crosses the Oakland Subdivision 550 feet east of the crossing. Major utilities and roadway infrastructure would need to be relocated, including street lighting, PG&E overhead power lines, gas, water, the drainage system along the roadway. The fiber optic and Kinder Morgan lines cross the street along the railroad and also would need to be relocated.

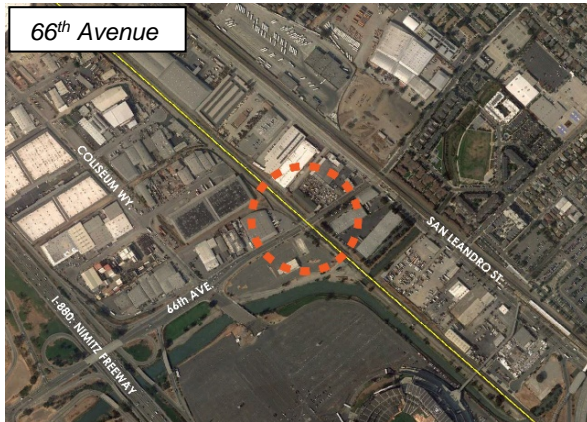
The 66th Avenue crossing is a four-lane roadway. The roadway crosses the three tracks at a 75-degree skewed angle. Sidewalks extend across the tracks on both sides of the roadway. Warning devices consist of two-quadrant flashing lights with gates located on the outside lanes. There appears to be adequate street lighting.

- Tracks at different elevations through crossing
- Worn stop lines with non-standard 2-foot-wide lines
- Sidewalks with substandard widths around sign posts, street lights, gate masts, and cantilevers
- Some broken channelization devices
- Westbound “No Stopping on Tracks” sign defaced; eastbound “3 Tracks” (W48CA) sign defaced
- None of the quadrants of the crossing are secure; vehicles may drive on the right-of-way (One car was witnessed driving on the right-of-way in the northwest quadrant)
- Large encampment along right-of-way to the southwest

- Surface tracks through crossing so they are at same elevation
- Repaint stop lines
- Remove homeless encampment in the southwest quadrant of railroad right-of-way
- Replace defaced “No Stopping on Tracks” and “3 Track” signs
- Widen sidewalk around obstructions
- Install partial 200-foot-long fence (100 feet on each side of the street) and maintenance access gates to each quadrant to deter trespassing
- Install “No Trespassing” signs in all quadrants
- Install new pavement markings and striping at crossing

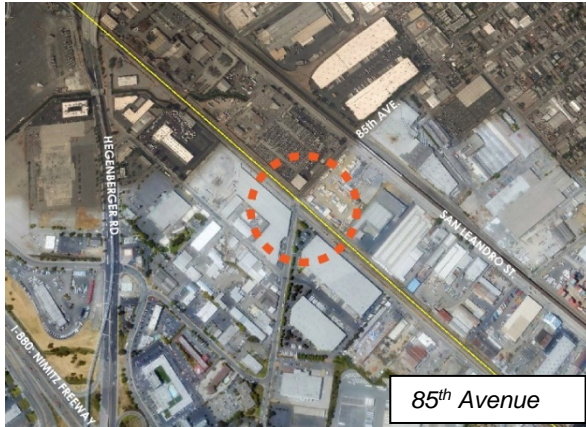
The 85th Avenue is a two-lane street that crosses the three tracks at 56 degrees. There are no sidewalks through the crossing. Warning devices consist of two-quadrant flashing lights with gates on the outside of the road. The crossing panels are in good condition.

- No sidewalks through the crossing
- Pavement markings are worn
- Railroad crossing warning (W10-1) and the

westbound “3 tracks” (W48 CA) signs missing in both directions

- Track is much higher than road and approaches are humped at the tracks
- Intersection with driveway and Railroad Avenue only 25 feet from crossing signal gate
- Homeless encampment in the southeast quadrant of the crossing
- Right-of-way fencing between Railroad Avenue and the tracks knocked down in places and with many holes
- No fencing in all four quadrants of the crossing to restrict access to the right-of-way
- “No Trespassing” signs missing

Due to the geometry of the road and proximity of the intersection with Railroad Avenue and the driveway, this crossing is a potential candidate for closure. If the crossing is to remain open, the recommended near-term safety enhancements include:

- Construct curbs, gutters, and sidewalks on both side of the road through the crossing
- Smooth out roadway approaches to panels
- Install four-quadrant crossing signal warning devices
- Repaint pavement markings and replace missing railroad warning signs
- Clear homeless encampment
- Install partial 200-foot-long fence (100 feet on each side of the street) and maintenance access gates to each quadrant to deter trespassing
- Install “No Trespassing” signs in all quadrants
- Install new pavement markings and striping at crossing

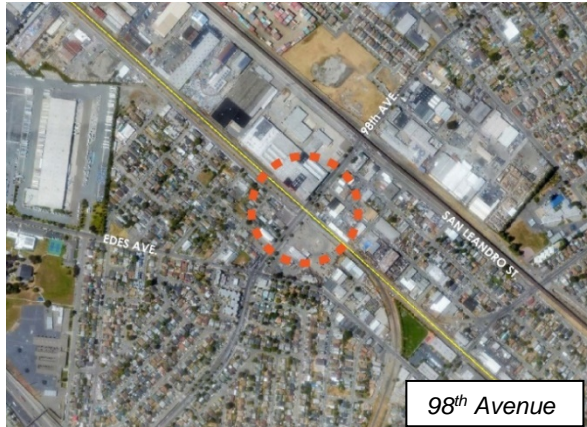
The Tier 1 98th Avenue is a four-lane street that crosses the two main tracks at 88 degrees. Sidewalks extend across the track on both sides of the roadway. The road has a concrete median that extends more than 100 feet to the east, but less than 60 feet to the west. Warning devices consist of two-quadrant flashing lights with gates located in the median and at the sides of the road. There appears to be adequate street lighting.

- Large trip hazards in the sidewalks where the sidewalks transition from concrete to asphalt
- Concrete median to the west not long enough to qualify as a supplemental safety measure
- Loose panels in the crossing
- Approaches to the crossing are humped at the tracks causing cars to slow down to cross
- Worn stop lines
- Railroad crossing warning signs (W10-1) missing in both directions
- Homeless encampment in the northeast quadrant of the crossing
- Fencing along Railroad Avenue knocked down in places and with many holes
- No fencing to restrict access to the right-of-way in any of the quadrants
- “No Trespassing” signs missing

- Construct a new median that fills in the gap between the two existing medians on the west side of the crossing; curbs will need to be modified at Railroad Avenue to restrict movements to right turns only; left turns can be handled from nearby Walter Avenue
- Replace the sidewalk to eliminate the tripping hazards
- Fix loose panels
- Repave approaches to crossing to smooth out profile
- Repaint stop lines
- Install missing railroad crossing warning signs
- Repair holes in the fence along Railroad Avenue
- Install partial 200-foot-long fence (100 feet on each side of the street) and maintenance access gates to each quadrant to deter trespassing
- Install new pavement markings and striping at crossing
- Install “No Trespassing” signs

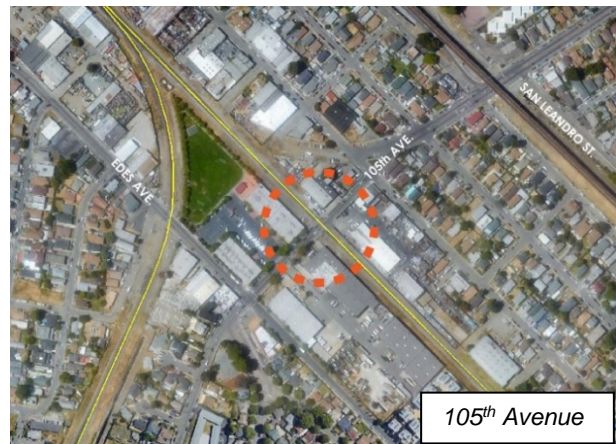
The Tier 1 105th Avenue crossing is a two-lane roadway. The roadway crosses one main track at a 90-degree skewed angle. Sidewalks extend across the track on both sides of the roadway. Warning devices consist of two-quadrant flashing lights with gates located on the outside lanes. The Sum Bible College School is located just west of the crossing.

- Power poles obstruct sidewalks
- Driveway to the southeast, angled towards the tracks, causes trucks to back out the driveway onto the tracks
- Damaged guardrail in northeast quadrant
- Railroad crossing warning signs (W10-1) missing in both directions
- Track is much higher than the east side of the road and approach is abrupt
- Large fences along right-of-way obstruct sight distances along tracks
- Northeast, southeast, and southwest quadrants of the right-of-way not fully fenced to prevent vehicles from accessing the right-of-way

- Relocate southeast driveway to be farther away from tracks
- Close the east driveway closest to the tracks and construct a 100-foot-long raised median on each side of the crossing
- Due to the proximity of the Sum Bible College, install pedestrian warning devices
- Underground overhead utilities in vicinity of the crossing to remove sidewalk obstructions
- Repave approaches to the crossing to smooth out profile
- Remove damaged guardrail
- Construct curb, gutter, and sidewalk through the crossing
- Install partial 200-foot-long fence (100 feet on each side of the street) and maintenance access gates to each quadrant to deter trespassing
- Install new pavement markings and striping at crossing

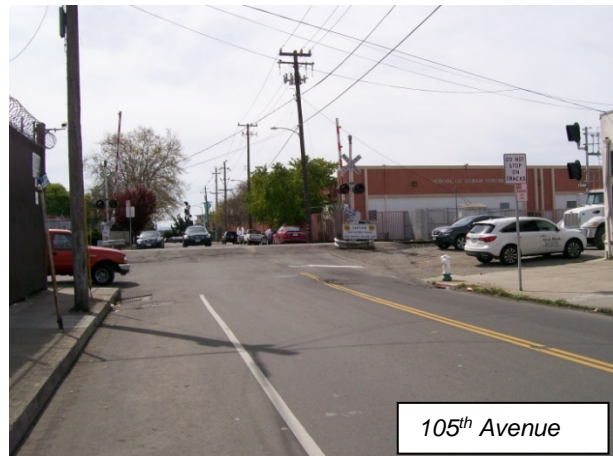
Grade Separation “Initial Scan”: As a Tier 1 crossing, HDR assessed the design options for a grade separation at 105th Avenue. Based on site observations, a 60-foot-long roadway underpass (60-foot-long railroad structure over the roadway) would likely be required at this location.

Based on experience with similar sites, the preferred railroad superstructure would likely consist of a one-span 60-foot-long rolled steel beam deck bridge with a steel ballast pan to bring the superstructure depth down to 6 feet from top of rail. For foundations, the abutments would need to be supported by large diameter CIDH or CISS piles, concrete columns, and precast concrete caps. The roadway profile would need to be depressed approximately 22 feet below the surrounding ground. A pump station would be required to pump stormwater out of the roadway portion of the underpass. The roadway profile conform points are approximately 500 feet to the west of the crossing 700 feet to the east of the crossing.

Access to the properties immediately adjacent to the tracks may need to be reconfigured or the property may need to be acquired. Major utilities and roadway infrastructure would need to be relocated, including street lighting, PG&E overhead power lines on both sides of the street, gas, water, sewer, and the drainage system along the roadway. A fiber optic line crosses the street along the railroad and also would need to be relocated.

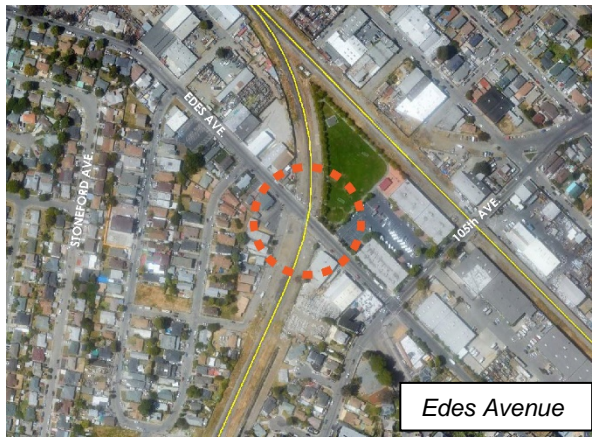
Edes Avenue is a two-lane roadway and is classified as a Tier 1 crossing. The roadway crosses the single main track at a 55-degree skewed angle. The track is in a curve through the crossing. Sidewalks extend across the tracks on both sides of the roadway. Warning devices consist of two-quadrant flashing lights with gates located on the outside lanes. There appears to be adequate street lighting. The Sum Bible College is adjacent to the railroad in the northeast quadrant.

- Broken crossing panel on the south side of the crossing, with its frame welded to adjacent panel
- No stop lines or railroad pavement markings
- Roadway approaches are humped at the crossing
- Sidewalks are uneven near the crossing
- Railroad right-of-way not fenced along Edes Avenue and Cary Avenue; there is only a railing to deter access

- Remove the railing and install 200-foot-long fence and gates in all quadrants and along Cary Avenue
- Install “No Trespassing” signs in all quadrants

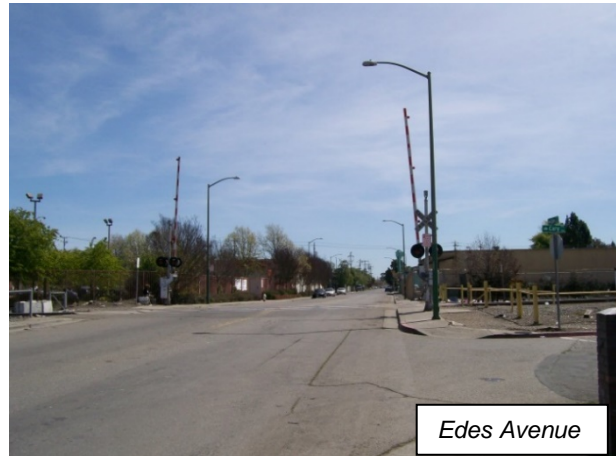
Grade Separation “Initial Scan”: As a Tier 1 crossing, HDR assessed the design options for a grade separation at Edes Avenue. Based on site observations, an 80-foot-long roadway underpass (80-foot-long railroad structure over the roadway) at this location would likely be required at this location.

Based on experience with similar sites, the preferred railroad superstructure would likely consist of a two-span 40-foot-long rolled steel beam deck bridge with a steel ballast pan to bring the superstructure depth down to 5 feet from top of rail. For foundations, the abutments would need to be supported by large diameter CIDH or CISS piles, concrete columns, and precast concrete caps. The roadway profile would need to be depressed approximately 22 feet below the surrounding ground. A pump station would be required to pump stormwater out of the roadway portion of the underpass. The roadway profile conform points are approximately 500 feet to the west of the crossing 700 feet to the east of the crossing.

Hale and Cary Avenues will need to be cul-de-sacs. Access to the properties immediately adjacent to the tracks may need to be reconfigured or the property may need to be acquired. Major utilities and roadway infrastructure would need to be relocated, including street lighting, gas, water, sewer, and the drainage system along the roadway. A fiber optic line crosses the street along the railroad and also would need to be relocated.

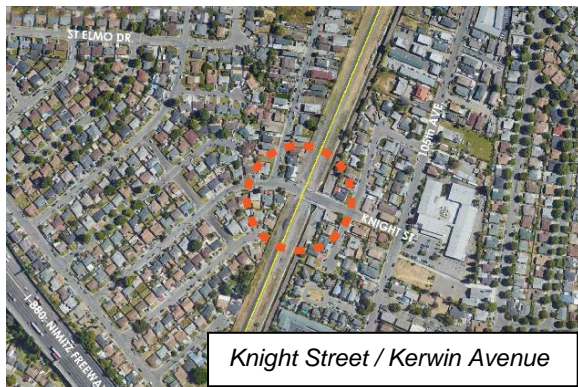
Knight Street / Kerwin Avenue is a two-lane street that crosses the single main track at 90 degrees. On both sides of the street, there are sidewalks through the crossing. Warning devices consist of 2-quadrant flashing lights with gates on the outside of the road. The crossing panels are in good condition. Aspire Lionel Wilson College Preparatory Academy is less than 500 feet to the east, and Sobrante Park Elementary School is in the vicinity of the crossing.

- Closest light to the east is over 100 feet from the gate, and closest to the west is over 50 feet (lighting through the crossing should be further studied)
- No striping, stop lines, or pavement markings
- “No Trespassing” signs are old and not legible
- The concrete-to-asphalt transition in the sidewalks is rough
- Cars parked near the crossing on the east side, reducing sight distance at the crossing
- Homeless encampments in the drainage channel right-of-way use the railroad right-of-way as access
- Damaged fence and gate in the southeast quadrant
- Banner posted on fence trying to discourage dumping instead encourages trespassing on the railroad right-of-way

- Paint striping, stop lines, and pavement markings on both sides of the crossing
- Replace damaged gate and fence in the southeast quadrant
- Replace “No Trespassing” signs
- Remove banner that encourages walking on the tracks
- Install street lighting closer to the east side of crossing; the additional lighting could possibly even help with the dumping problem in the area
- Reconstruct sidewalk to remove bump at areas transitioning from concrete to asphalt
- Construct a raised median 60 feet to the west and 100 feet to the east; the median will affect two residential driveways and the drainage channel driveways
- Due to proximity of schools in the area, install pedestrian gates in the opposing direction of travel
- Clear encampments in drainage channel property
- Repair damaged fence used to access property

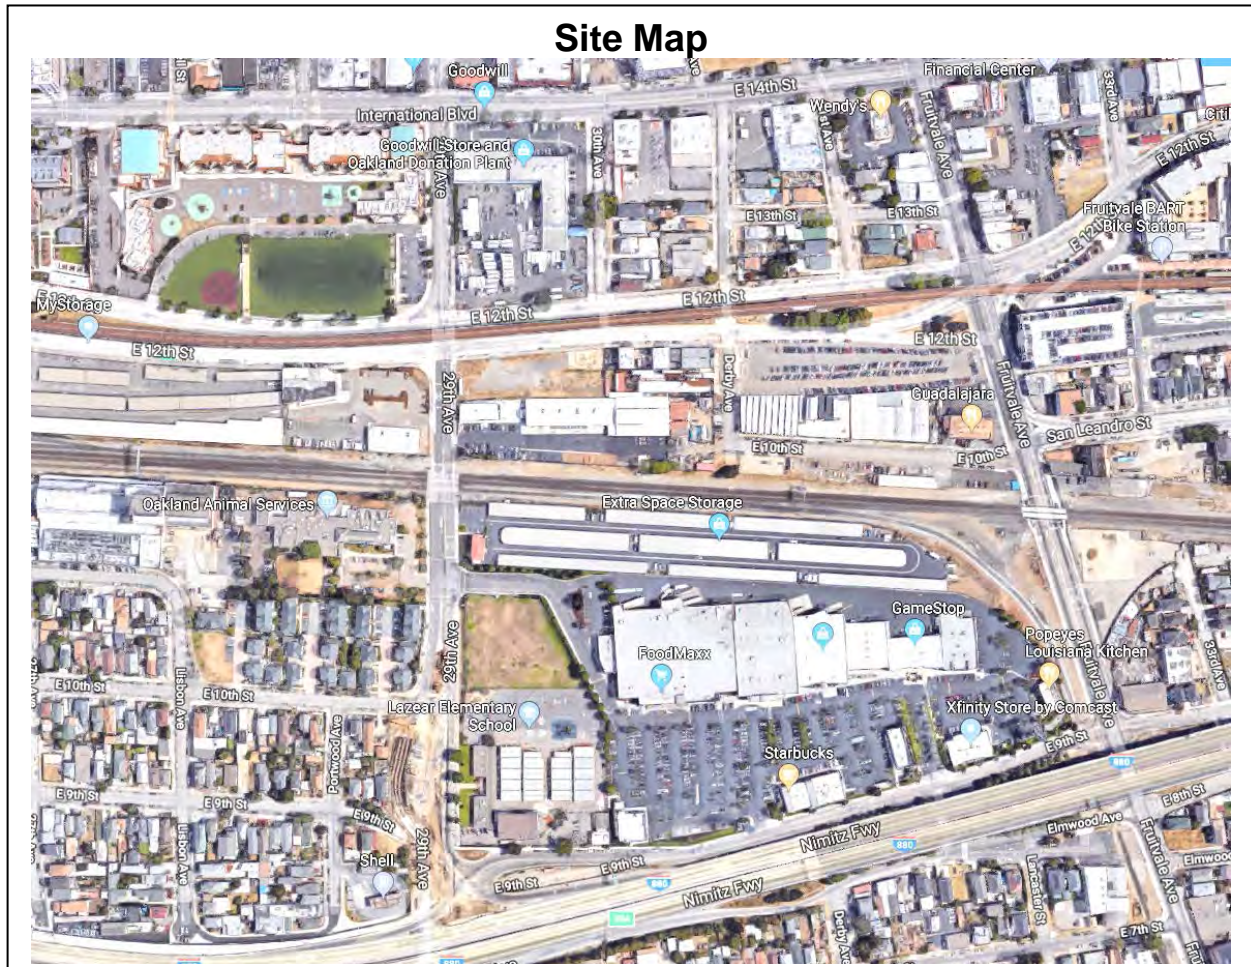
Crossing Characteristics	Existing Condition
Track Characteristics:	Speed: 79-60 Rail Wt. <u>136</u> CWR; Joint Locations: Trk 161 Jtd rail with Comp joint near xing Crossing Surface: Concrete Panels Crossing Length: 73' <u>3</u> Tracks: MT1, MT2, Track 161 General Condition: OK
Crossing Warning Devices	Type: Flashing light warning device with crossing gates - BFG Location: FL and Gates in NE and SW quadrants are behind sidewalk. SW gate over road to avoid OHP. Signal House SW. Condition: Up to current standards.
Roadway Characteristics	Posted Speed: 25MPH Surface: AC Width: Road widens at crossing. 48'E/64'W Crossing Angle: 86d Center Medians: No, W Median ends before the xing. Curbs/Shoulders Sidewalk is not wide enough, poles impede access.
Adjacent Intersections	International Blvd – 830'E E 12 th St Signalized Intersection – 275'E Epic Charter School Driveway – 75'E ExtraSpace Storage Driveway - 55'W Commercial business Signalized Intersection - 190'W 10 St/Start of freeway overpass is on other side of intersection – 490'W

Existing Utilities	In Roadway: Street lights both sides of street, SDCBs all quadrants, FH SW, OHP S, Telcom MH S, Gas and water N S/W. Along RR: FO W, KM & FO E, Old steel lattice towers between MT1 and Yard Track (161).
Geometric Issues/Constraints	BART Aerial Structure – 315'E
Pedestrian Activity	Yes, Epic Charter School adjacent E and Lazear Elementary School 200' W. Trespassers spotted.
Bicycle Activity

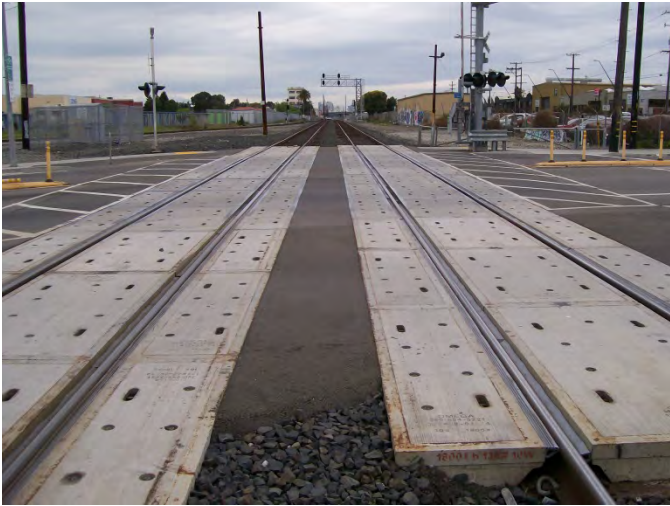
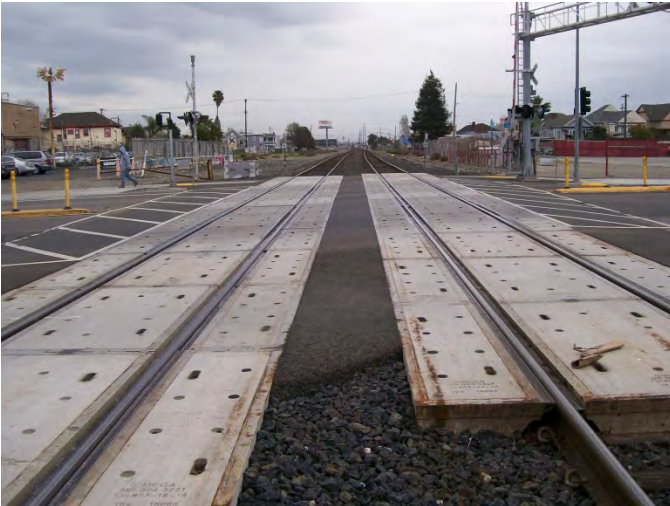
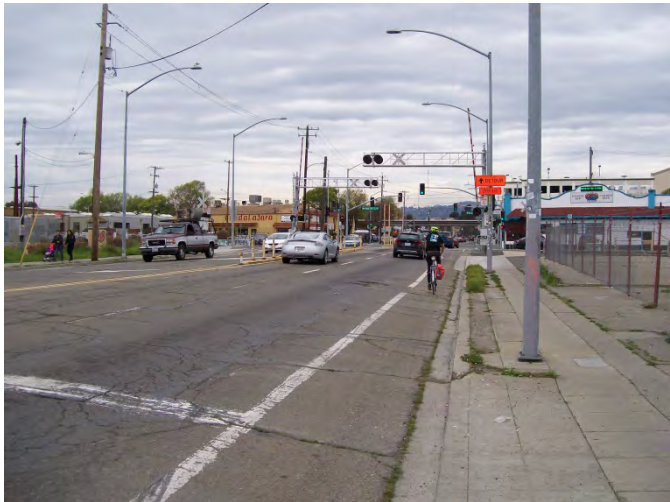
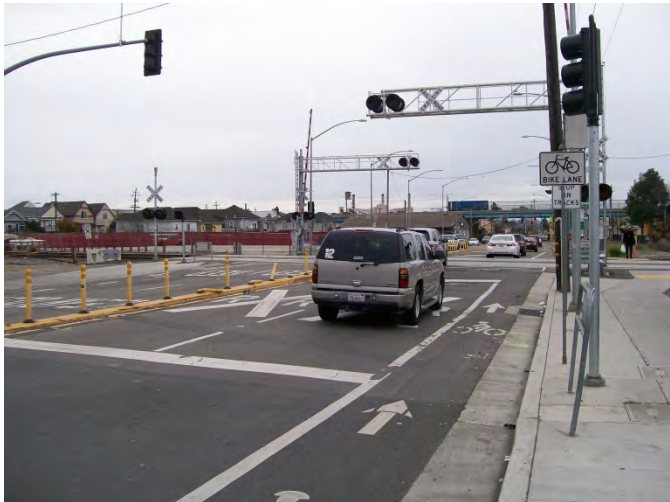
Comments	<ul style="list-style-type: none"> • Potential SSM for QZ include – Median with channelization devices has been constructed. • Crossing is candidate for closure. – No, Fruitvale BART access, I-880 underpass, and Connection to Alameda. • Missing circular RxR signs (W10-1 and 2 tracks sign-W48 CA). • SW Railroad pavement markings are worn. • Crossing is signalized in conjunction with San Leandro St intersection. • Dynamic Envelope striped and hatched on pavement.
----------	-----------------------------------------------------------------------------------------------------------------------------------------------------------------------------------------------------------------------------------------------------------------------------------------------------------------------------------------------------------------------------------------------------------------------------------------------------------------------------------------------------------------------------------------------

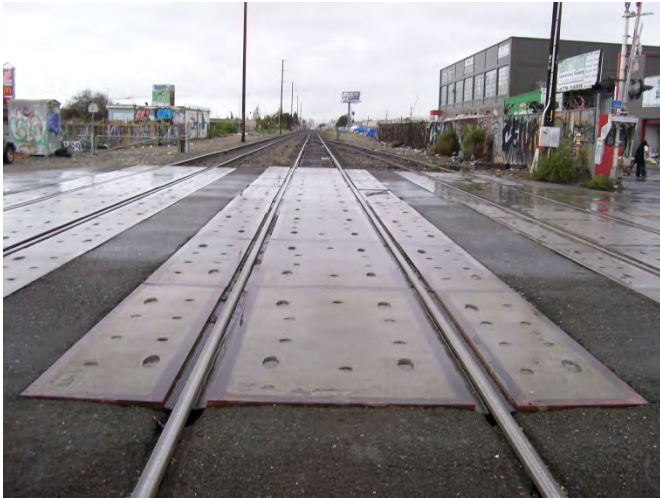
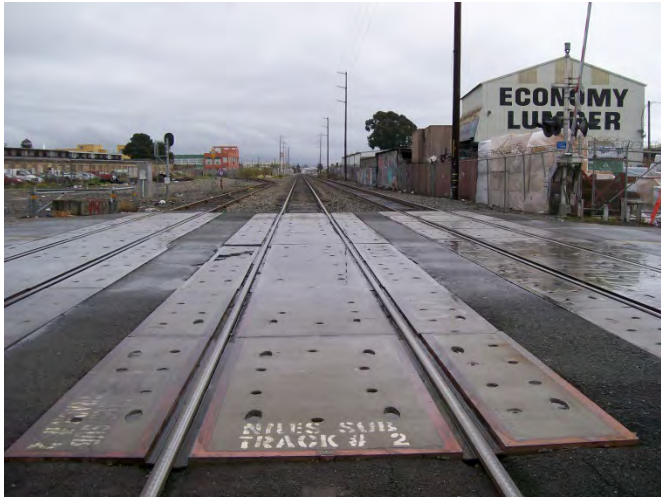
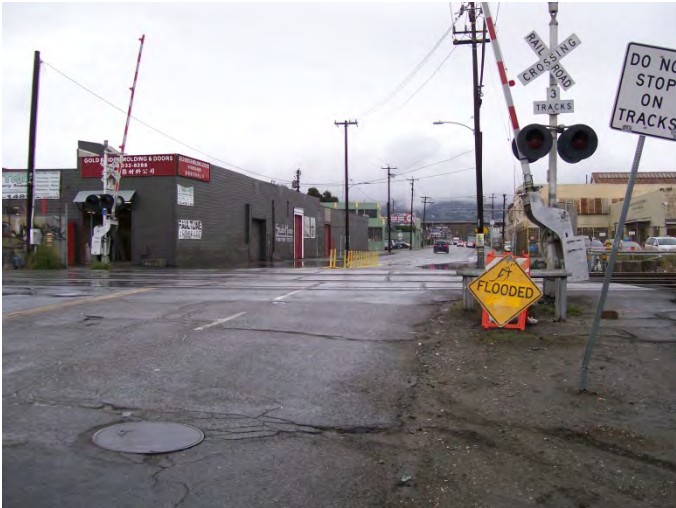
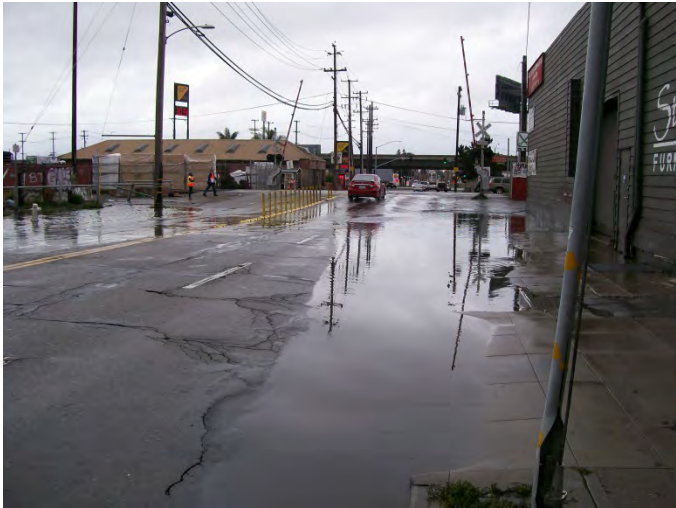
Comments	<ul style="list-style-type: none"> • Potential SSM for QZ include –Driveways are too close to crossing to have medians. • Crossing is candidate for closure. – No, I-880 underpass and ramps, connects to Alameda. • Large encampment to NE of crossing. • Drainage problem on east side of road. Flooding appears to have stalled a car after the crossing. This backed up the street, leading to cars stopping on the tracks. • Missing circular RxR signs (W10-1 and 2 tracks sign-W48 CA). Both directions • Railroad pavement markings are worn, both directions. • Old Gate foundation and guardrail in SW quadrant. • No trespassing signs are small and have been defaced. • Barricade gate unlocked.
----------	------------------------------------------------------------------------------------------------------------------------------------------------------------------------------------------------------------------------------------------------------------------------------------------------------------------------------------------------------------------------------------------------------------------------------------------------------------------------------------------------------------------------------------------------------------------------------------------------------------------------------------------------------------------------------------------------------------------------------------------------------------------------------------------------------

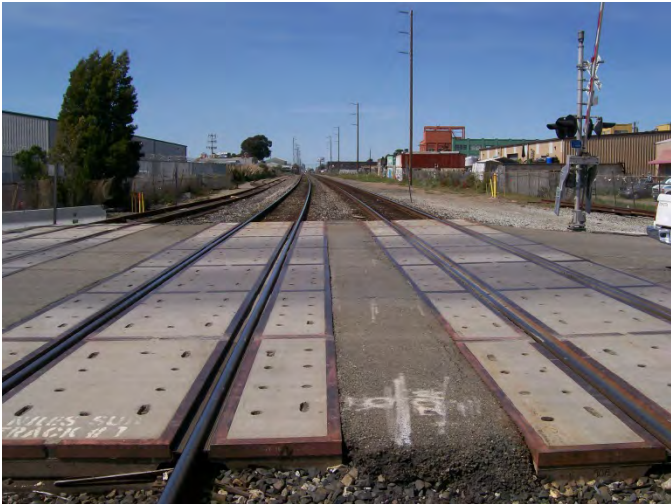
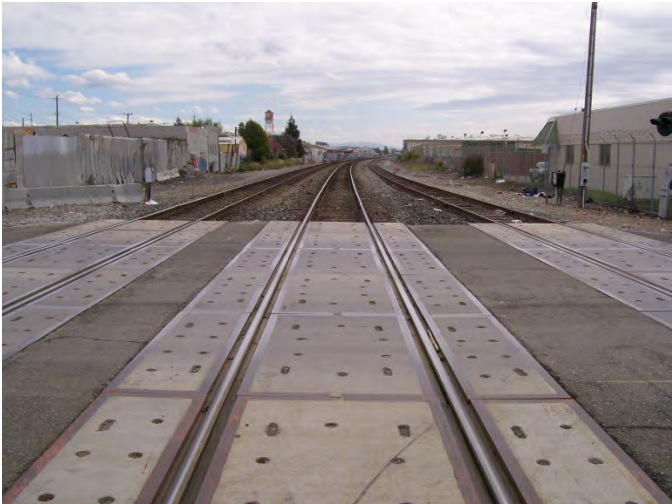
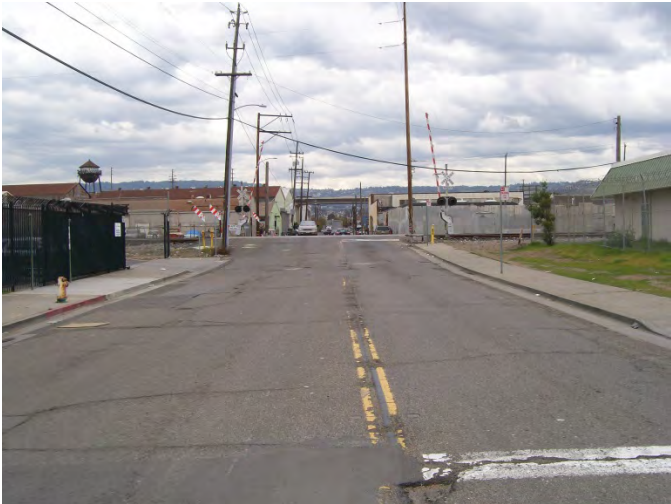
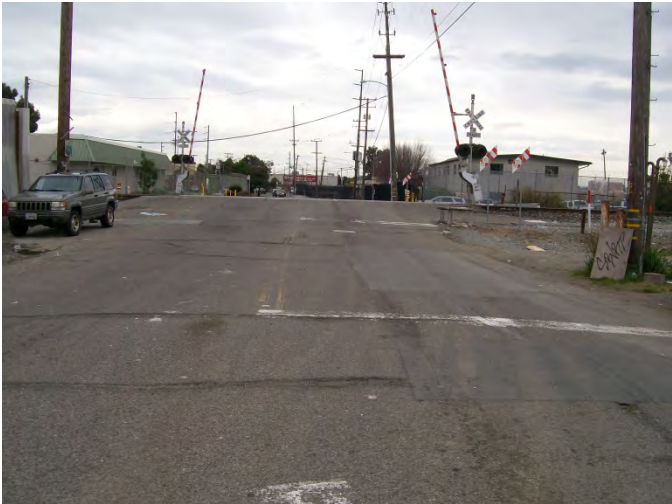
Geometric Issues/Constraints	Curve to the 300'W. Possible sight distance issue on other side of track because track is higher than roadway.
Pedestrian Activity	5 people midday.
Bicycle Activity	1 spotted crossing with gates down (no train crossed).
Available Right-of-Way	No, adjacent lots occupied.

Comments	<ul style="list-style-type: none"> • Potential SSM for QZ include – Driveways are too close. Trucks entering property to NW would have difficulty entering with a median. • Crossing is candidate for closure. – Yes, though it would create a 1.25Mi stretch between High St and 66th Ave with no crossing. • Signs of encampment on railroad R/W. • Railroad pavement markings worn. • No circular RxR sign (W10-1) or 3 tracks signs (W48 CA). • Old gate foundations and guard rails were left in place. • Pavement near panels has been scraped repeatedly. Cars nearly going airborne over crossing.
----------	--------------------------------------------------------------------------------------------------------------------------------------------------------------------------------------------------------------------------------------------------------------------------------------------------------------------------------------------------------------------------------------------------------------------------------------------------------------------------------------------------------------------------------------------------------------------------------------------------------------------------------------------------------------------------------------------
