Memo

Project: Alameda Rail Corridor and Crossings Assessment

Subject: Oakland Rail Corridors and Crossings

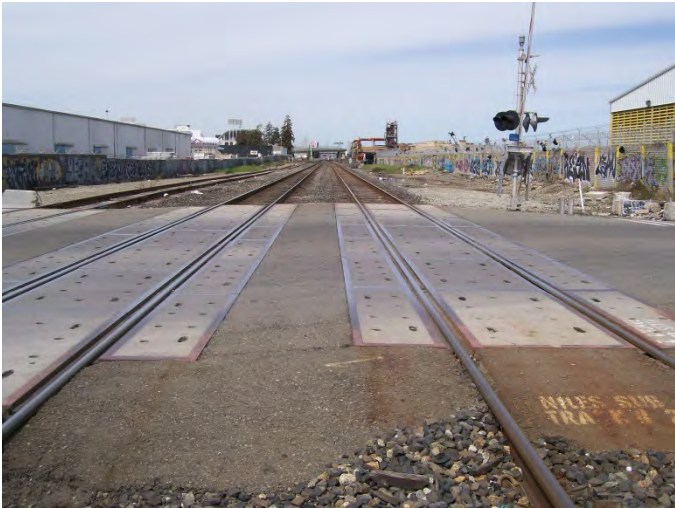
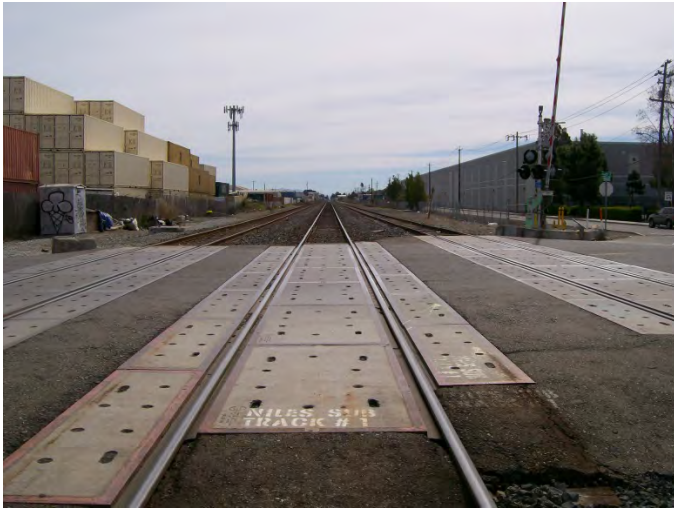
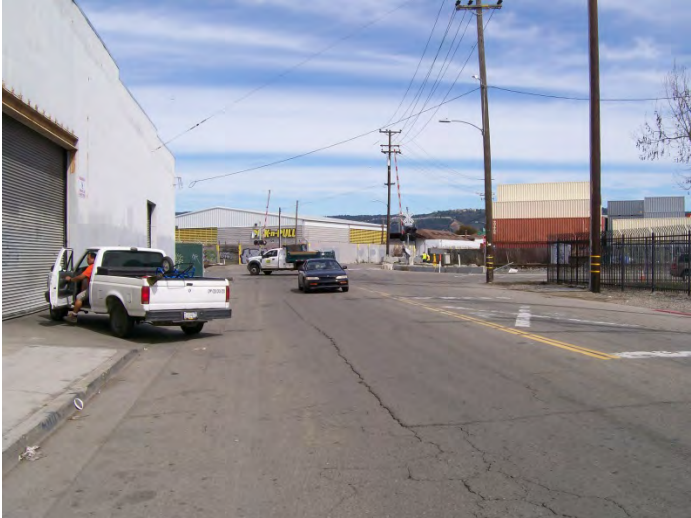
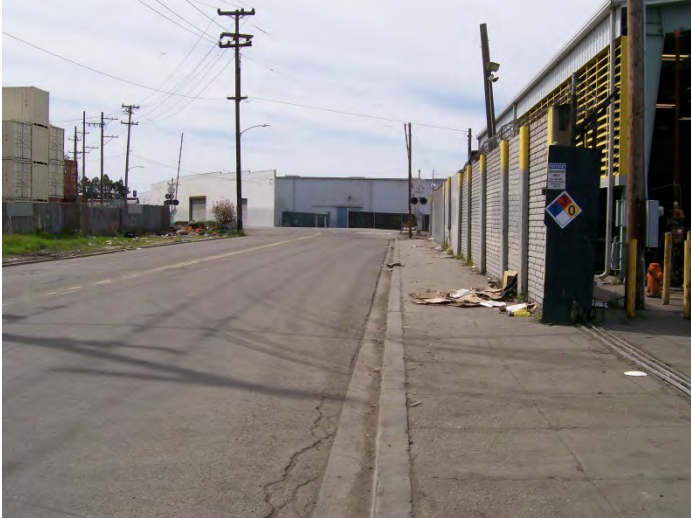
Crossing Characteristics	Existing Condition
Track Characteristics:	<p>Speed: 79-60</p> <p>Rail Wt. <u>136</u> CWR; Joint Locations: Trk 179 jtd. Compromised joints very close to xing.</p> <p>Crossing Surface: Concrete Panels</p> <p>Crossing Length: 57'MTs – 65' Trk 179</p> <p><u>3</u> Tracks: MT1, MT2, Trk 179. Trk 179 appears to be out of service (frog has been removed from turnout on south end).</p> <p>General Condition: OK</p>
Crossing Warning Devices	<p>Type: Flashing light warning device with crossing gates - BFG</p> <p>Location: Gates on sides of road. Signal house SE with power drop NE.</p> <p>Condition: OK.</p>
Roadway Characteristics	<p>Posted Speed: 25 MPH</p> <p>Surface: AC</p> <p>Width: 36-44'</p> <p>Crossing Angle: 56d</p> <p>Center Medians: None</p> <p>Curbs/Shoulders: None. Need curb and sidewalks throughout crossing. Pedestrians must enter road and cross in front of gates. SW corner needs curb for gate (currently protected by ultrablocks and rail bollards).</p>

Comments	<ul style="list-style-type: none"> • Potential SSM for QZ include – Construct median with channelization devices E of crossing. • Crossing is candidate for closure. Yes. • Fence along Railroad Ave. has multiple holes. • Barricade NW quadrant has been knocked out. Possible to drive on SE right-of-way. • No “No trespassing signs” • Encampment in SE quadrant. • Track is much higher than road and approaches to crossing are abrupt. • Striping is worn and W10-1 and W48 (CA) signs are missing in both directions. • NW driveway is close to crossing and may pose problems for adjusting approaches. Fencing appears to be encroaching on sidewalk.
----------	---------------------------------------------------------------------------------------------------------------------------------------------------------------------------------------------------------------------------------------------------------------------------------------------------------------------------------------------------------------------------------------------------------------------------------------------------------------------------------------------------------------------------------------------------------------------------------------------------------------------------------------------------------------------------------------------------------------------------------------------------------

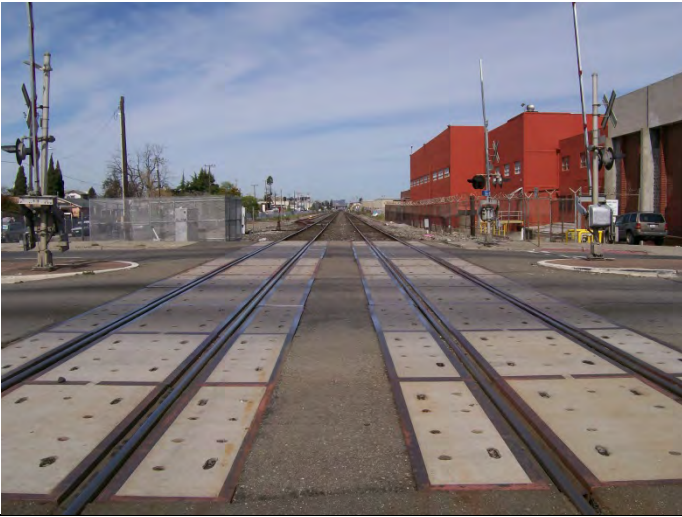
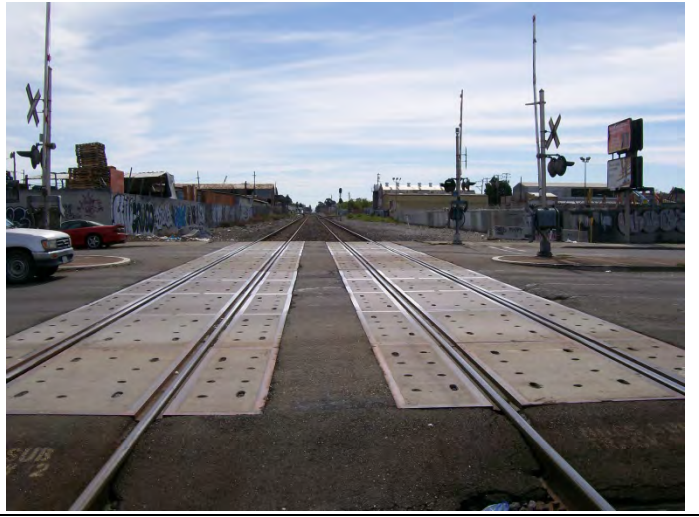
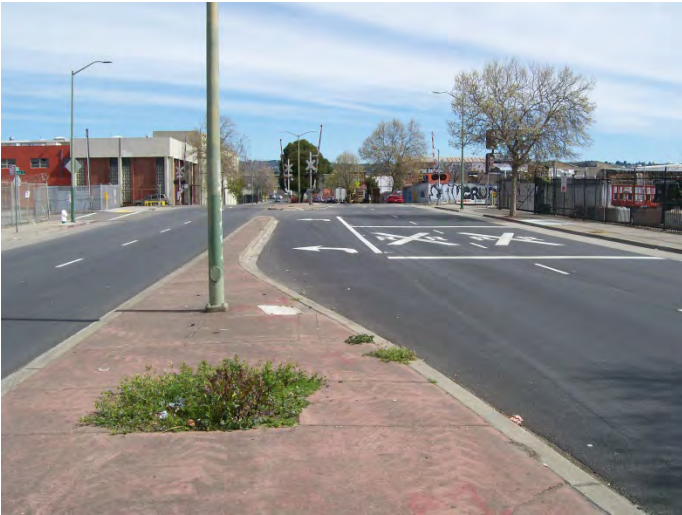
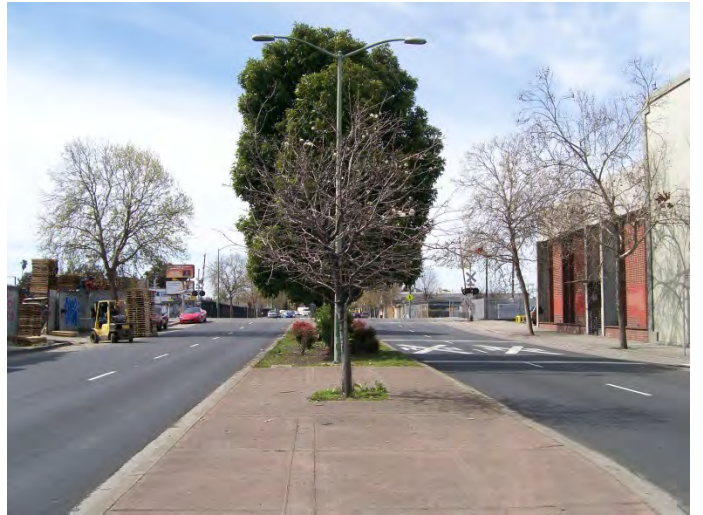
Comments	<ul style="list-style-type: none"> • Potential SSM for QZ include –Extend median on west side, limiting Railroad Ave. and driveway to right turn only. • Crossing is candidate for closure. No. • Fence along Railroad Ave. has multiple holes. • Gap in fence • No Barricade NW quadrant and SW has been moved. • No “No trespassing signs” • Encampment in NE quadrant. • Track is much higher than road and approaches to crossing are abrupt. Cars have to slow down to safely use crossing. • Stop lines are worn and W10-1 and W48 (CA) signs are missing in both directions. • Asphalt pavement at the interface with the concrete sidewalk has large lip creating a tripping hazard right at the tracks
----------	-----------------------------------------------------------------------------------------------------------------------------------------------------------------------------------------------------------------------------------------------------------------------------------------------------------------------------------------------------------------------------------------------------------------------------------------------------------------------------------------------------------------------------------------------------------------------------------------------------------------------------------------------------------------------------------------------------------------------------------------------------------------------------------------------------------------

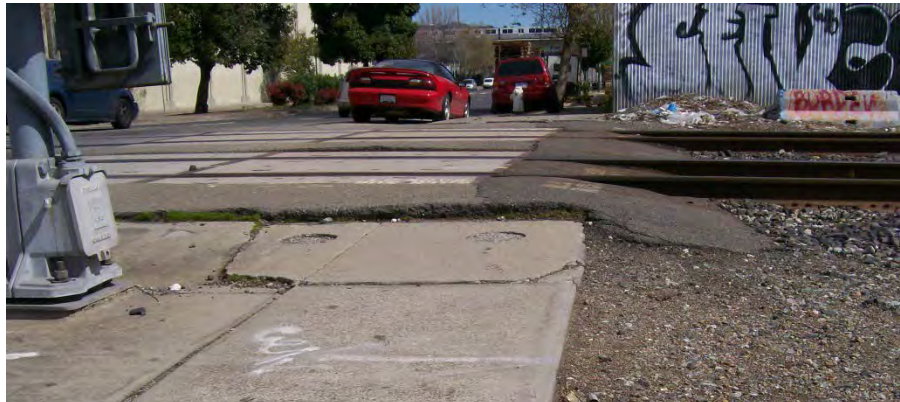
Tripping hazard in sidewalk

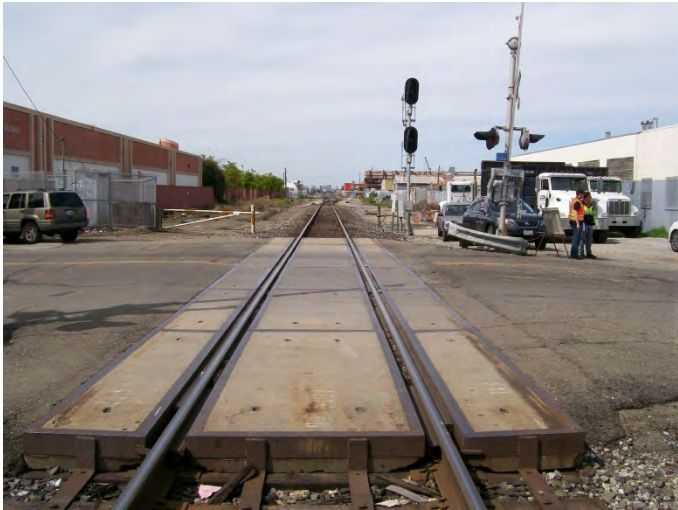
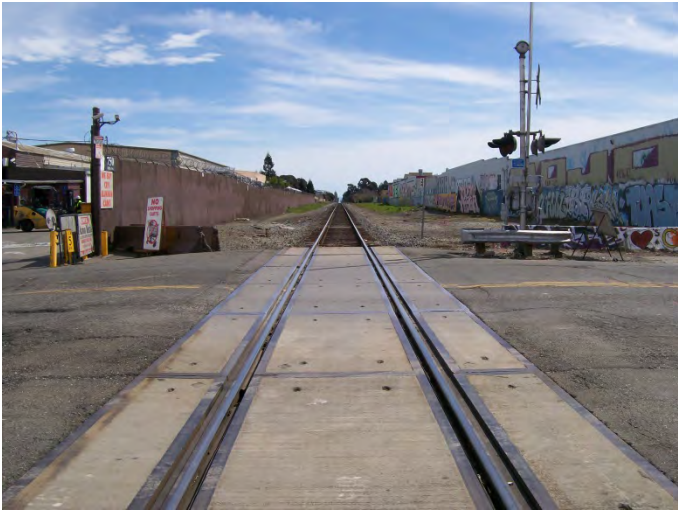
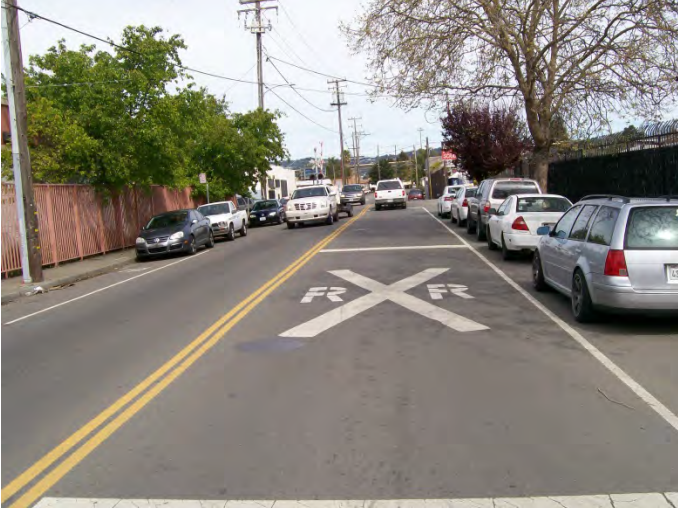
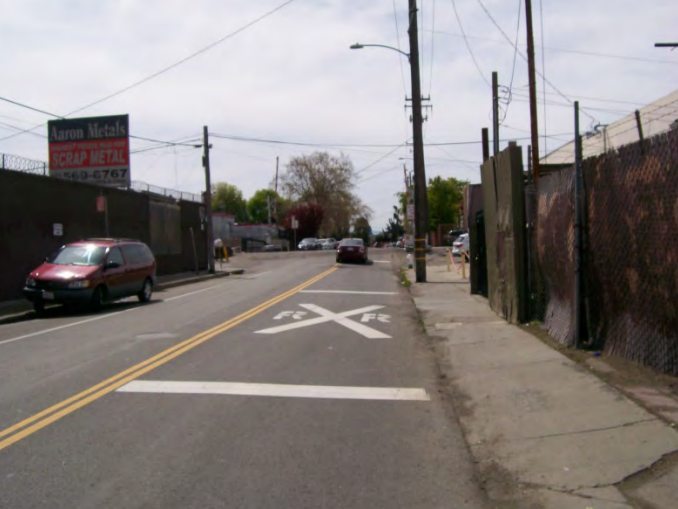
Comments	<ul style="list-style-type: none"> • Potential SSM for QZ include – Construct median with channelization devices both sides of crossing. • Crossing is candidate for closure. Needs to be studies, because it is only crossing between 98th and Davis St and adjacent to school. • Stop lines are far from gates. • Scrap metal fence SE and signal house and fence NW obstruct sight down tracks. • No “No trespassing signs” • Track is much higher than east side of road and approach to crossing is abrupt. • W10-1 signs are missing in both directions. EB - Do not stop on tracks sign is present. Scrap metal business appears to place additional caution signs at crossing. • SE driveway to scrap metal business driveway is facing tracks and street. Representative from business approached us on site visit and seemed to be receptive to improving safety on street. Mentioned they looked at moving driveway. Utility and sidewalk improvements may have deterred them. • Power poles are obstructing sidewalk.

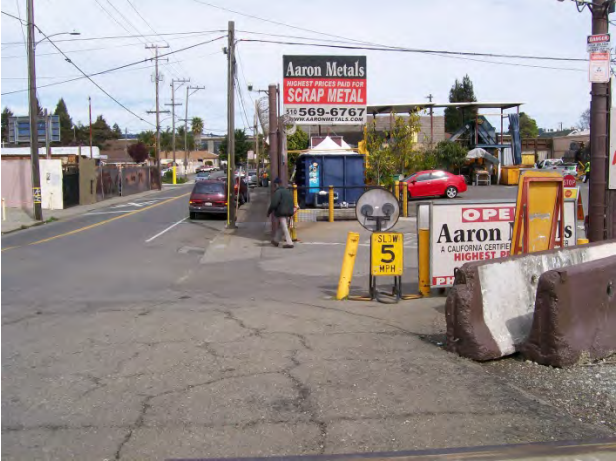
Driveway Photo taken from tracks

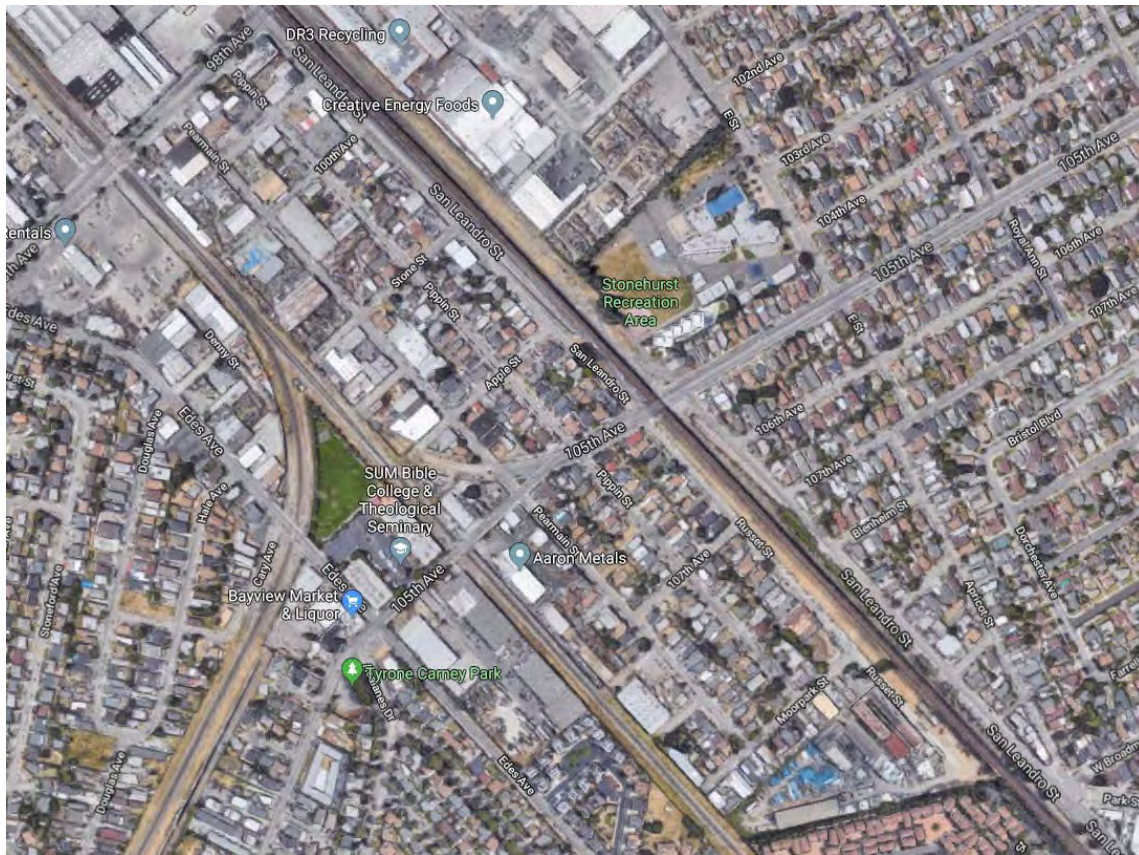
Site Map

Crossing Characteristics	Existing Condition
Track Characteristics:	Speed: 15-15 (50-40 Sign to South of Xing) Rail Wt. <u>136</u> CWR; Joint Locations: Crossing Surface: Concrete Panels Crossing Length: 70' <u>1</u> Track: MT General Condition: Broken gauge panel. Panels are welded and not level in south sidewalk
Crossing Warning Devices	Type: Flashing light warning device with crossing gates - BFG Location: Sides. NW House with power drop. Sidewalks behind gates. RR signal to NE Condition: OK
Roadway Characteristics	Posted Speed: 25 MPH Surface: AC Width: 38' (shoulders + lane each direction) Crossing Angle: 55d Center Medians: None Curbs/Shoulders: Shoulders, curbs, gutters, and sidewalks all present. Sidewalk AC-Concrete interface should be fixed.
Adjacent Intersections	Douglas Ave – 630'N Hale Ave – 275'N Cary Ave – 45'N School Driveway – 113'S 105 th Ave - 410'S
Existing Utilities	In Roadway: High Voltage Vault – N, Street Lights both sides, SD, Telcom, Water, PG&E – S Along RR: KM-W, FO-W, AT&T in Cary Ave.

Geometric Issues/Constraints	
Pedestrian Activity	Bus Stop nearby, Encampment to North, New school set to open in fall – NE.
Bicycle Activity	
Available Right-of-Way	No.

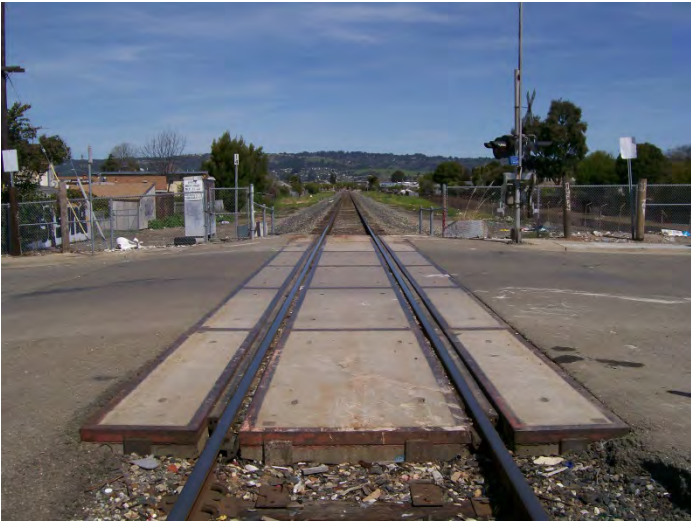
RR Looking North

Comments	<ul style="list-style-type: none"> • Encampments in channel R/W adjacent to RR R/W. Use RR for access through holes in the fence. • No striping or pavement markings • Rough transition from concrete sidewalk to AC pavement. • SE fence is damaged. • No trespassing signs are old. • Dumping on sidewalks and RR R/W. Surveillance camera and sign to the west of crossing. "Think before you dump" sign showing kids walking on tracks to the east.
----------	---------------------------------------------------------------------------------------------------------------------------------------------------------------------------------------------------------------------------------------------------------------------------------------------------------------------------------------------------------------------------------------------------------------------------------------------------------------------------------------------------------------------

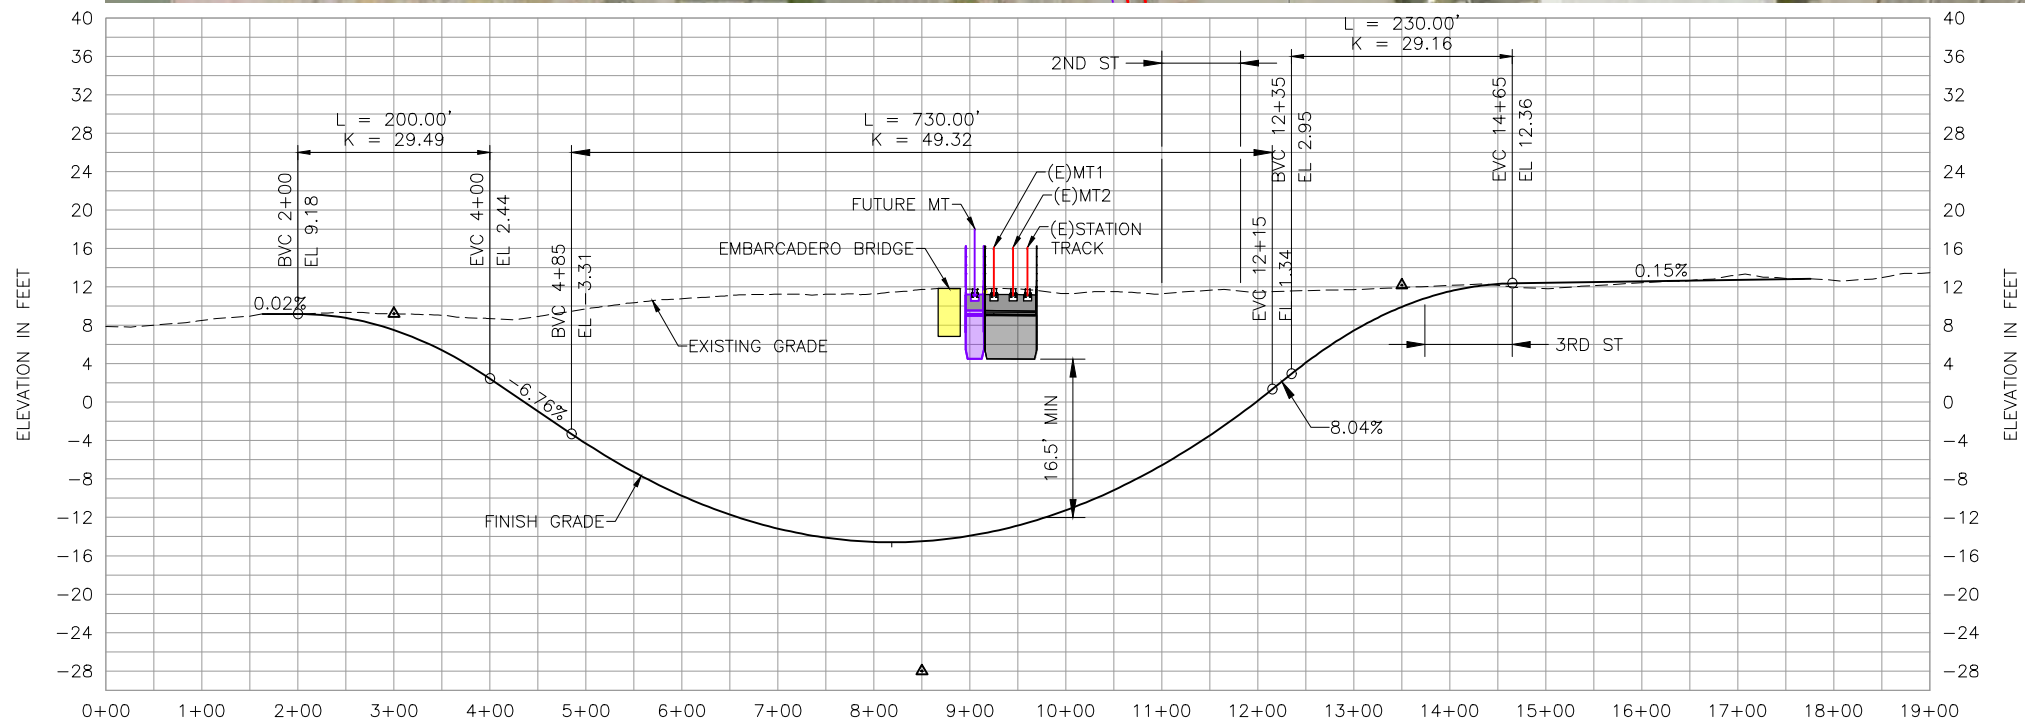
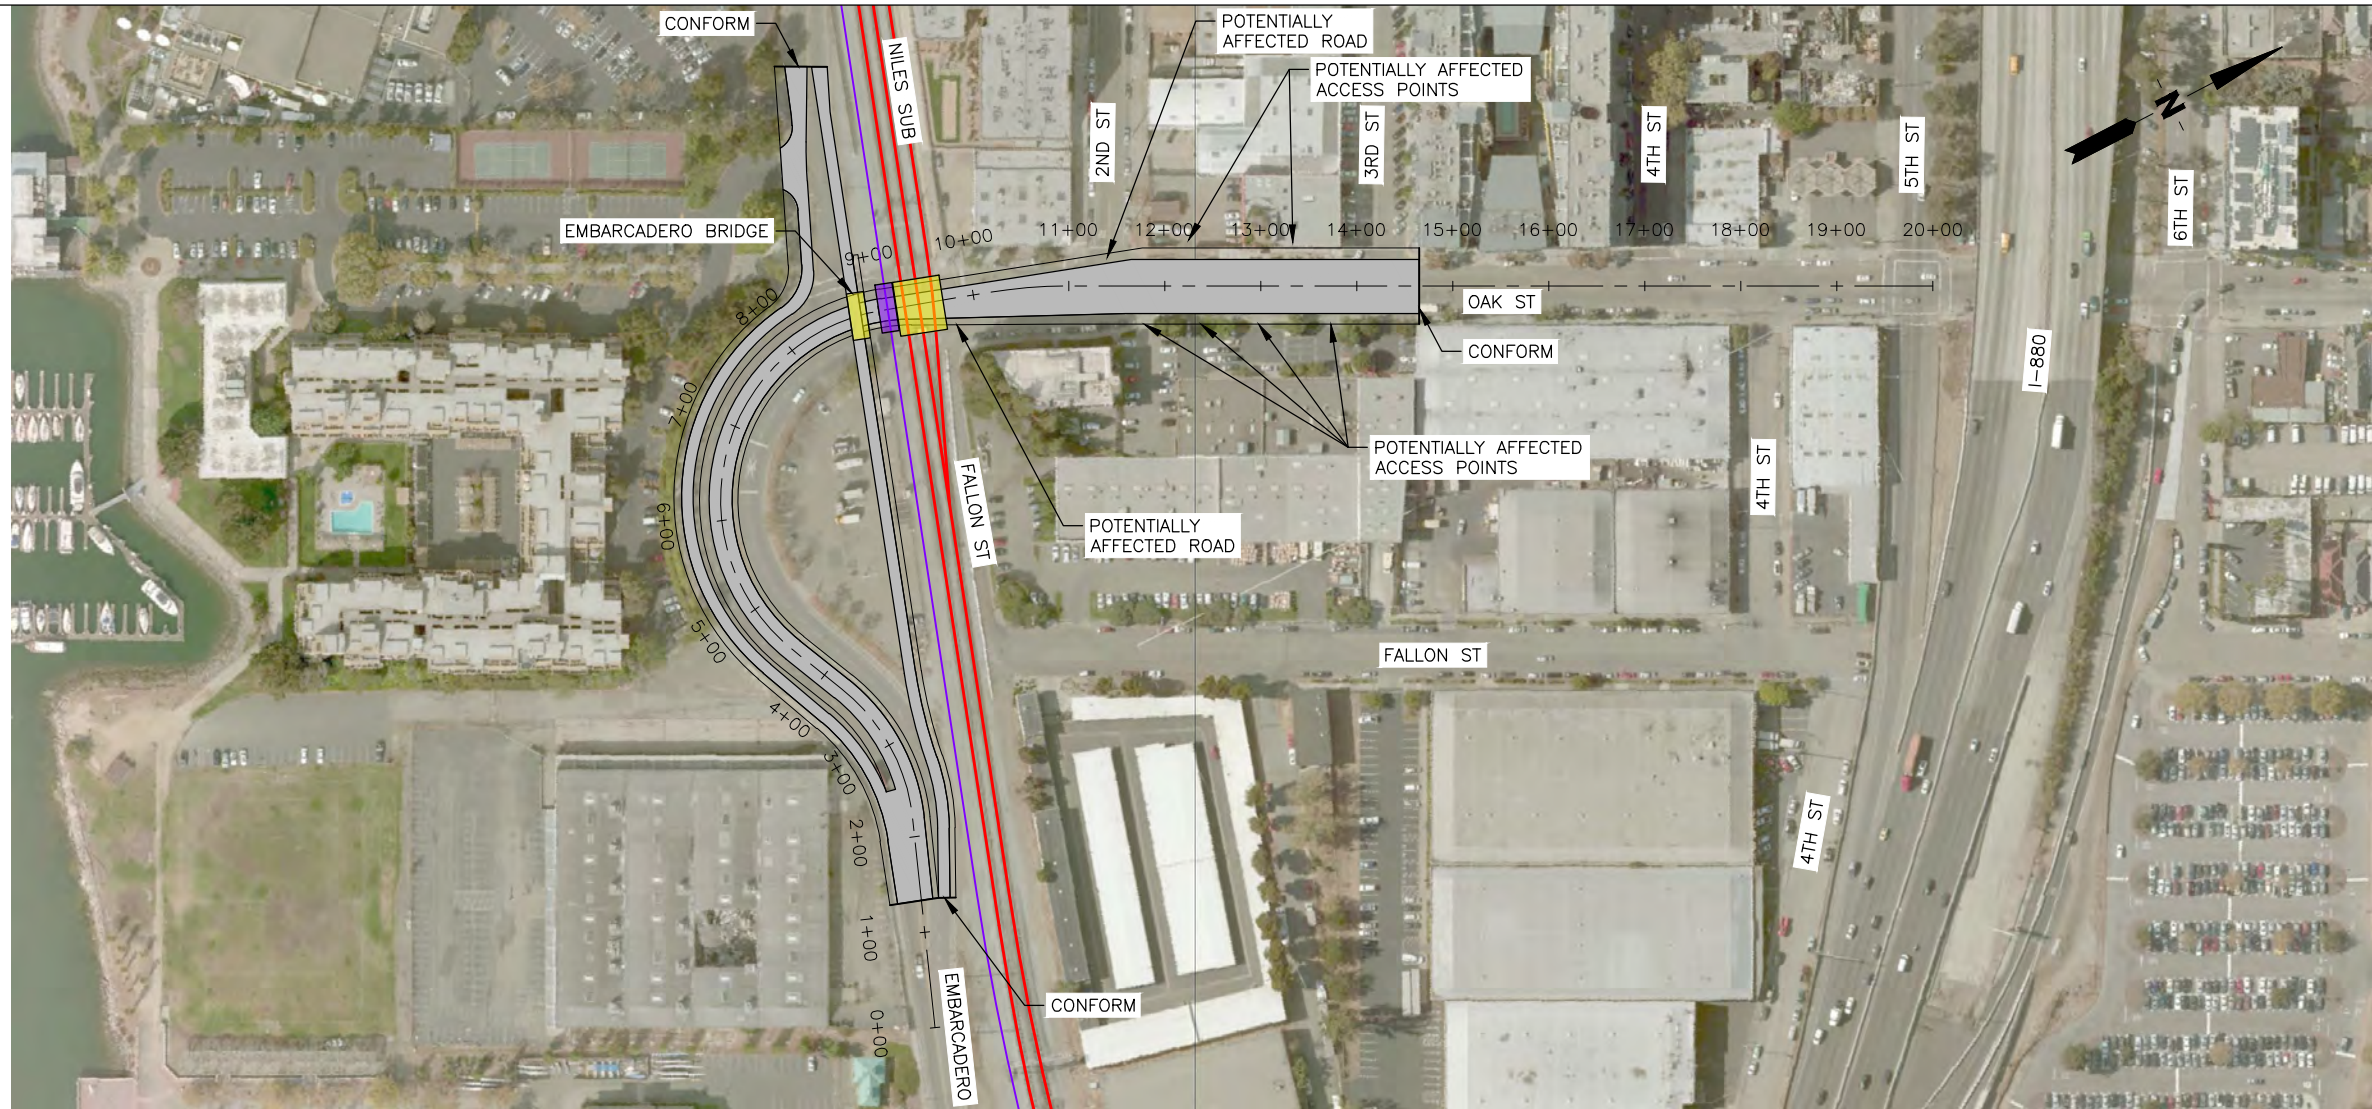
DRAWN BY:	BK	ALAMEDA COUNTY TRANSPORTATION COMMISSION
CHECKED BY:	KC	LOCATION: OAK ST
DATE:	4/16/18	NILES - JACK LONDON SQUARE, OAKLAND
SHEET NUMBER		DWG TITLE: ROADWAY UNDERPASS EXHIBIT

railroad structure over the roadway) would likely be required at this location. Based on experience with similar sites, the preferred railroad superstructure type would likely consist of a two-span 50-foot-long rolled steel beam deck bridge with a steel ballast pan to bring the superstructure depth down to 6 feet from top of rail. For foundations, the center pier and abutments would need to be supported by large diameter Cast-in-Drilled Hole (CIDH) or Cast-in-Steel Shell (CISS) piles, concrete columns, and precast concrete caps. The roadway profile would need to be depressed approximately 21 feet below the surrounding ground. A pump station would be required to pump stormwater out of the roadway portion of the underpass. The roadway profile conform points are approximately 450 feet to the east to limit the effects to the intersection with 3rd Street. To the west, the conform point extends approximately 900 feet.

Oak Street would likely be categorized as a lower priority grade separation due to its relatively low daily traffic counts relative to other Tier 1 crossings. **Appendix B1** includes an exhibit of the conceptual grade separation, as well as profile and typical section at Oak Street.

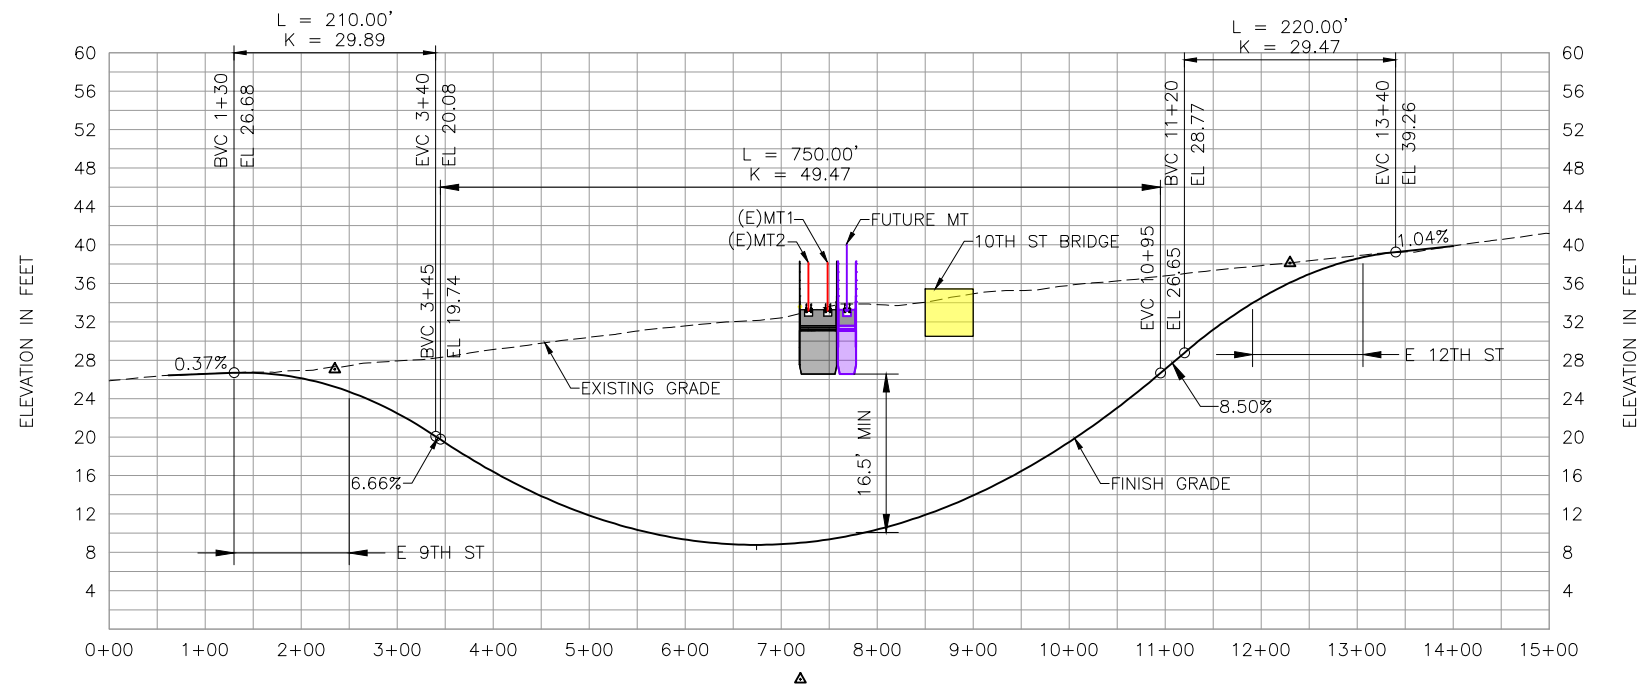
DRAWN BY: BK	ALAMEDA COUNTY TRANSPORTATION COMMISSION
		CHECKED BY: KC	
		DATE: 5/4/18	
		SHEET NUMBER	
		LOCATION: FRUITVALE AVE NILES - EAST OAKLAND	
		DWG TITLE: ROADWAY UNDERPASS EXHIBIT

Based on experience with similar sites, the preferred railroad superstructure type would likely consist of a two-span 55-foot-long rolled steel beam deck bridge with a steel ballast pan to bring the superstructure depth down to 6 feet from top of rail. For foundations, the center pier and abutments would need to be supported by large diameter CIDH or CISS piles, concrete columns, and precast concrete caps. The roadway profile will need to be depressed approximately 20 feet below the surrounding ground. A pump station would be required to pump stormwater out of the roadway portion of the underpass. The roadway profile conform points are approximately 650 feet on either side of the crossing.

Pending additional studies, the Fruitvale Avenue crossing may be categorized as a mid- to high-priority grade separation due to its relatively high daily traffic counts relative to other Tier 1 crossings. **Appendix B1** includes an exhibit of the conceptual grade separation, as well as profile at Fruitvale Avenue.

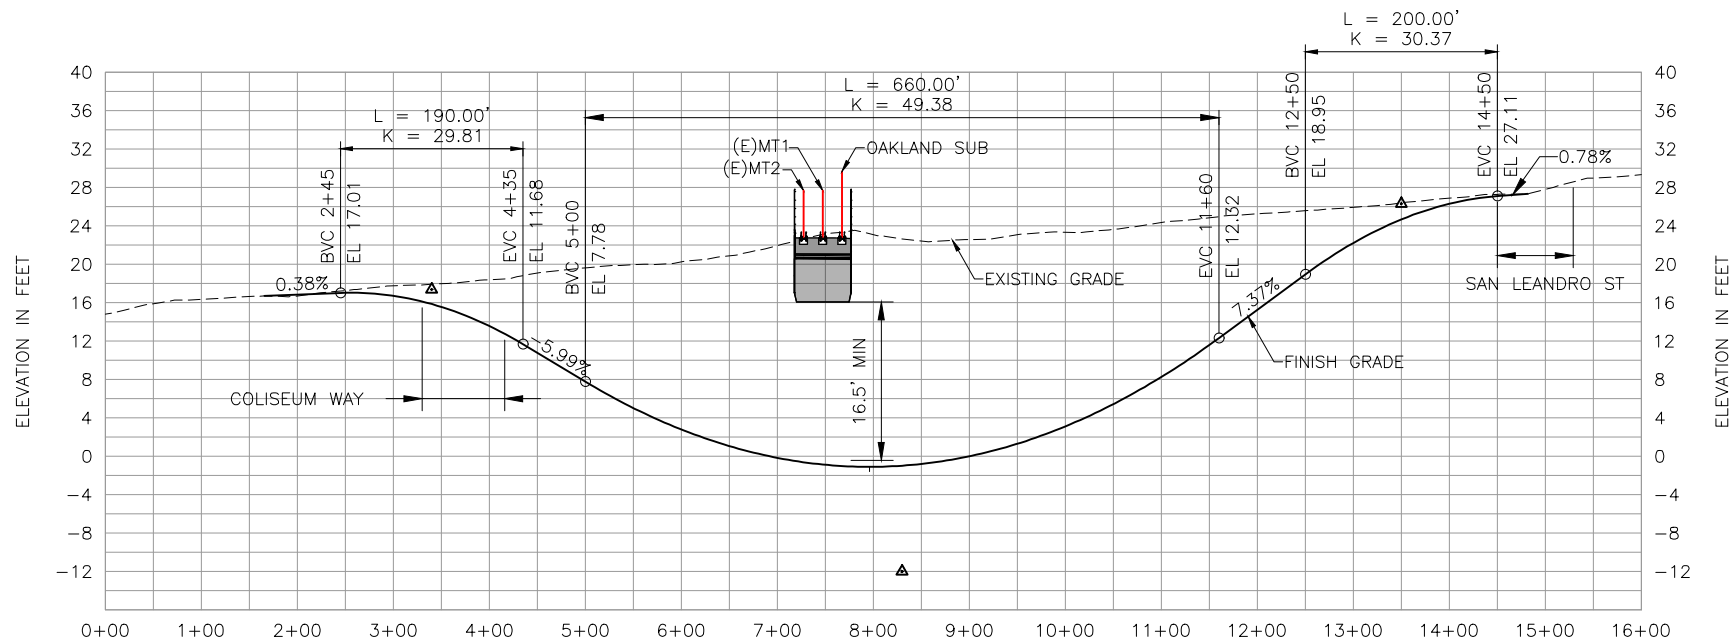
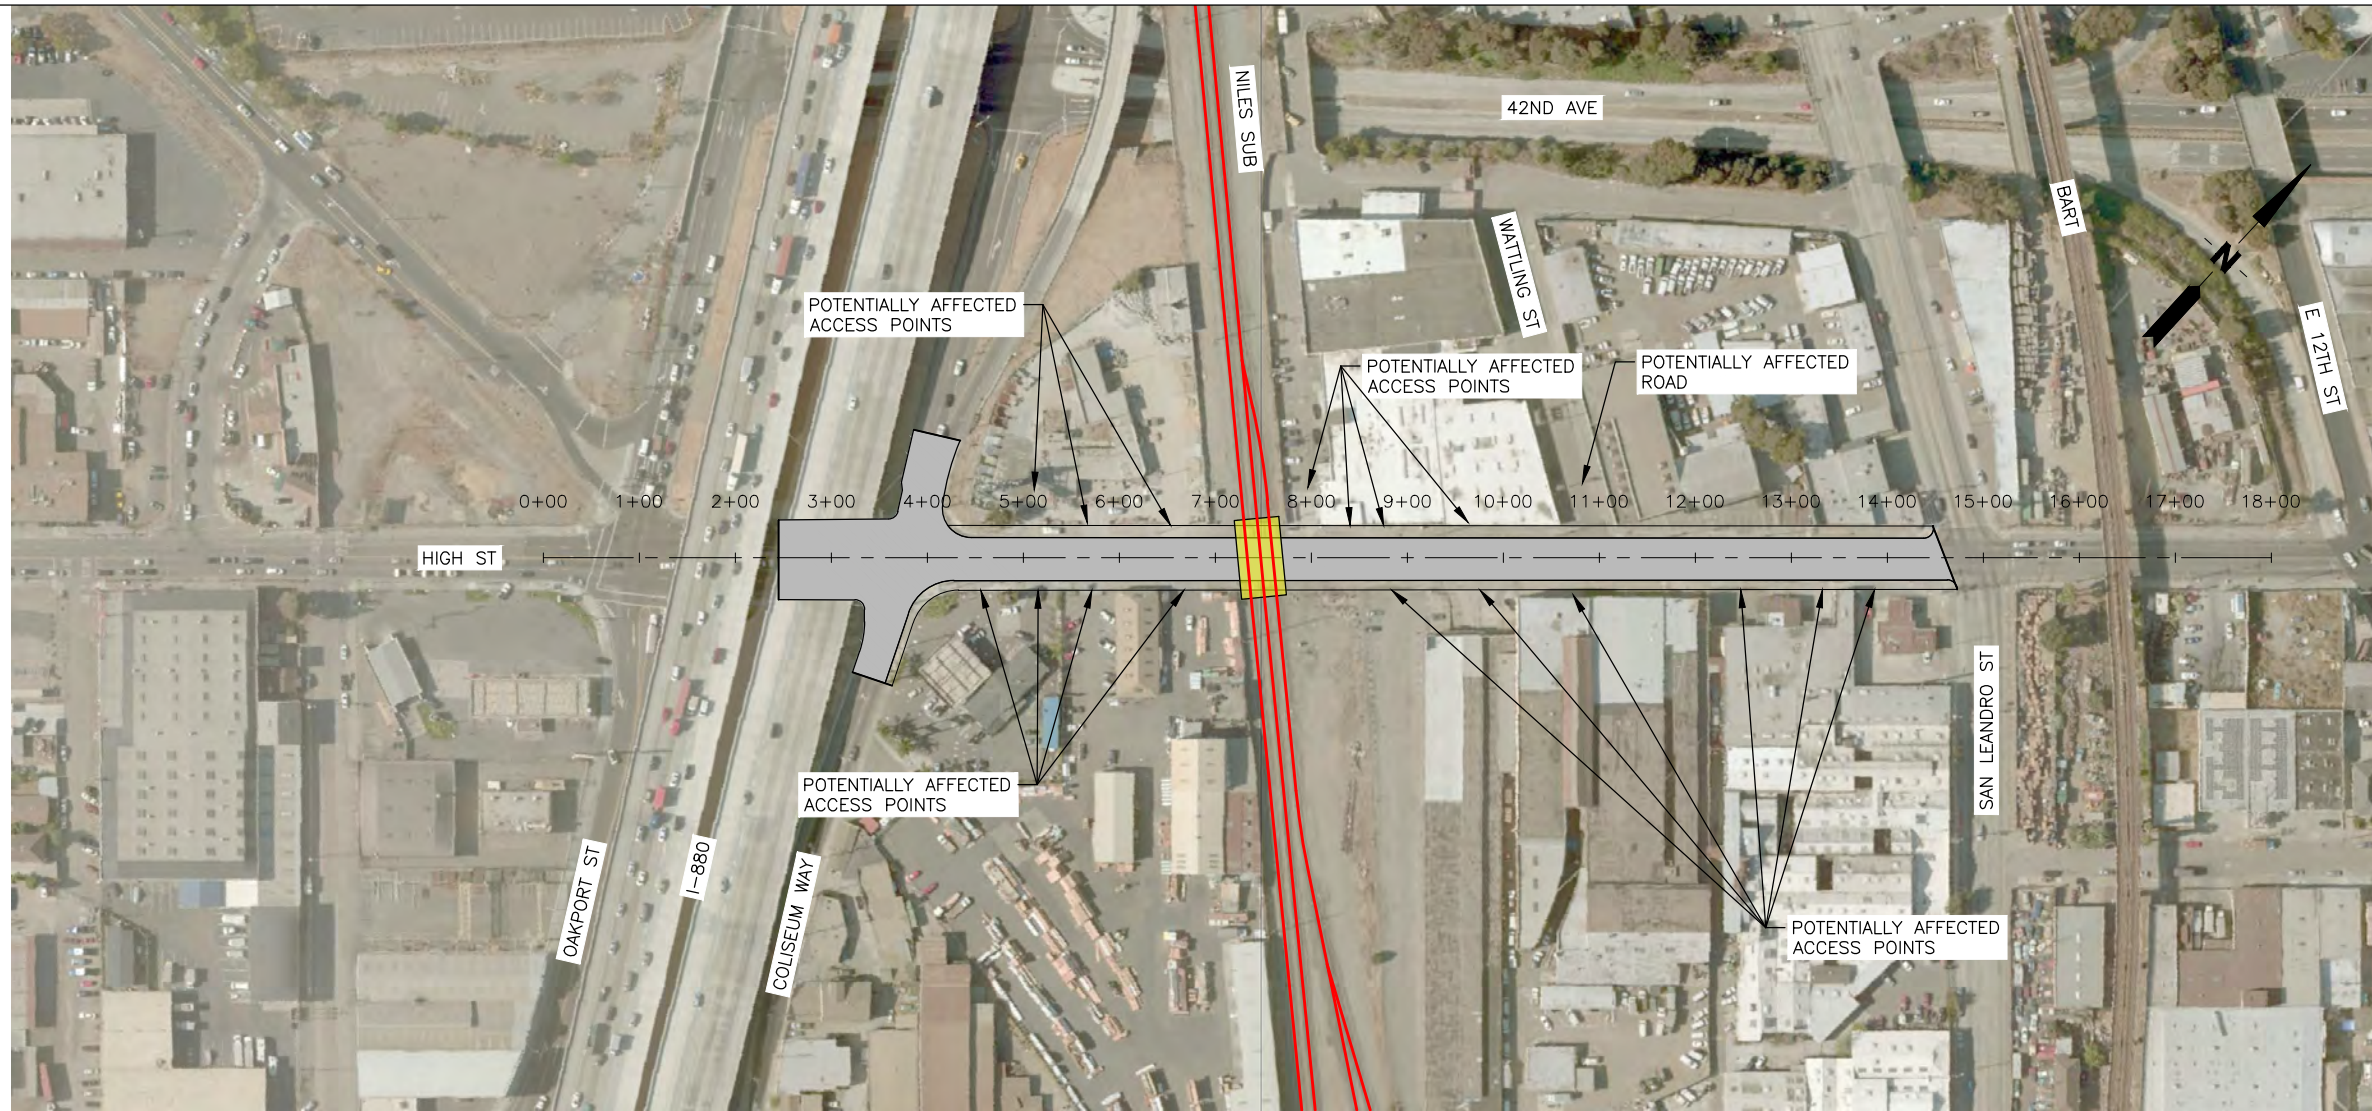
DRAWN BY: BK	ALAMEDA COUNTY TRANSPORTATION COMMISSION
		CHECKED BY: KC	
		DATE: 4/16/18	
		SHEET NUMBER	
		LOCATION: HIGH ST NILES - EAST OAKLAND	
		DWG TITLE: ROADWAY UNDERPASS EXHIBIT

Grade Separation “Initial Scan”: As a Tier 1 crossing, High Street is a potential candidate for a grade separation. Based on site observations, the High Street grade separations may need to be viewed as part of a larger freeway access improvement project. The recommended grade separation is a 90-foot-long roadway underpass (90-foot-long railroad structure over the roadway) at this location.

HDR assessed the design options for a grade separation at High Street. Based on experience with similar sites, the preferred railroad superstructure would likely consist of a two-span 45-foot-long rolled steel beam deck bridge with a steel ballast pan to bring the superstructure depth down to 6 feet from top of rail. For foundations, the center pier and abutments would need to be supported by large diameter CIDH or CISS piles, concrete columns, and precast concrete caps. The roadway profile would need to be depressed approximately 20 feet below the surrounding ground. A pump station would be required to pump stormwater out of the roadway portion of the underpass. The roadway profile conform points are approximately 500 feet to the west of the crossing 700 feet to the east of the crossing.
