Memo

Project: Alameda Rail Corridor and Crossings Assessment

From: Cathy LaFata and Wayne Short, HDR

Subject: Fremont Rail Corridors and Crossings

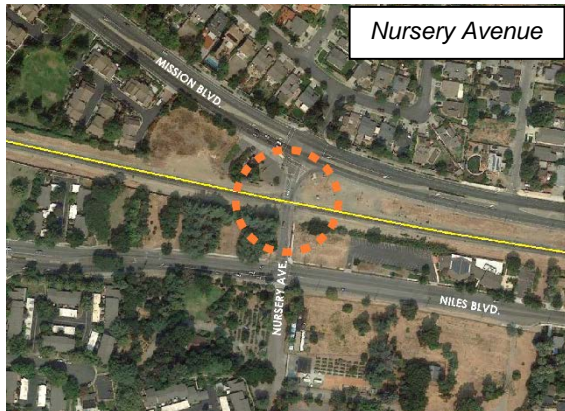
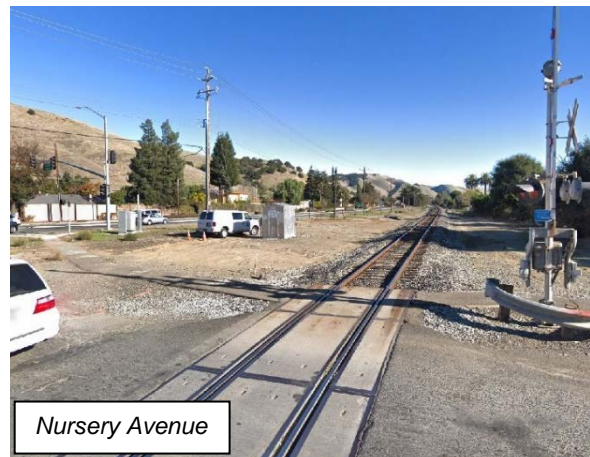
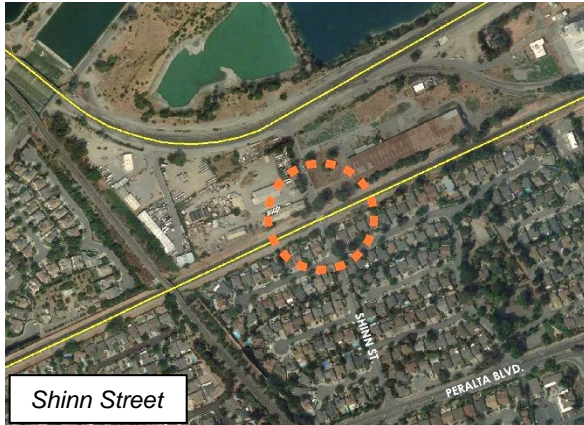
3.2.1 Nursery Avenue

The Nursery Avenue crossing is a two-lane roadway located within the City of Fremont just north of the Niles District. The roadway crosses the track at a 90-degree angle and the posted speed is 25 mph. The roadway is approximately the same grade as the railroad. There is an asphaltic concrete (AC) sidewalk on the south side and no sidewalk on the north side of the crossing. Warning devices consist of two-quadrant flashing lights with gates, one set for each direction. The crossing panels, signage, and pavement markings are in good condition; however, the roadway surface is in poor

condition. There appears to be adequate street lighting at the adjacent intersections, but there are no street lights at the crossing.

Potential deficiencies noted in the site visit include:

- AC pavement deteriorated
- No sidewalk on north side
- AC sidewalk is not ADA-compliant
- No raised median in both approaches allowing vehicles to drive around gates
- No street lights at crossing
- Right-of-way open to public on both sides of crossing all quadrants

Recommended near-term safety enhancements include:

- Repair AC pavement
- Add Portland Concrete Cement (PCC) ADA-compliant sidewalks to both sides of crossing
- Install street lights at the crossing
- Add pedestrian warning devices in opposite directions
- Add raised median on both approaches and relocate driveway in northwest quadrant
- Install partial 200-foot-long security fence (100 feet on each side of the street) and maintenance access gates to each quadrant to deter trespassing
- Upgrade signal interconnect for Quiet Zone

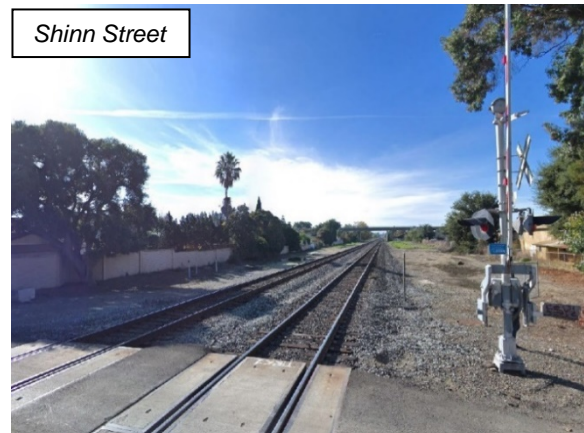
3.2.2 Shinn Street

The Shinn Street crossing is located within the City of Fremont on the eastern portion of the Centerville Line. It is a two-lane street that crosses the Niles Subdivision at 86 degrees. This crossing has two mainline tracks the roadway is approximately the same grade as the railroad. The speed limit is 25 mph. There are no sidewalks on either side of the crossing. Warning devices include one set of flashing lights and gates for each direction. There is a street light at the crossing.

Potential deficiencies noted in the site visit include:

- No sidewalks on either side of crossing
- No raised medians on either approach preventing vehicles from driving around gates
- No warning devices on the opposite quads for pedestrians in opposite direction
- Right-of-way at all four quadrants open to the public for trespassing
- Chain-link gates are located in the northwest and northeast quadrants; however, they are not continuous and pedestrians can walk around them

Recommended near-term safety enhancements include:

- Install ADA-compliant concrete sidewalks on both sides
- Add one set of flashing lights (Standard CPUC No.8s) to each of the opposite quadrants for pedestrians in opposite direction
- Install 100-foot-long raised median on both sides of the crossing
- Install partial 200-foot-long security fence (100 feet on each side of the street) and maintenance access gates to each quadrant to deter trespassing
- Install “No Trespassing” signs

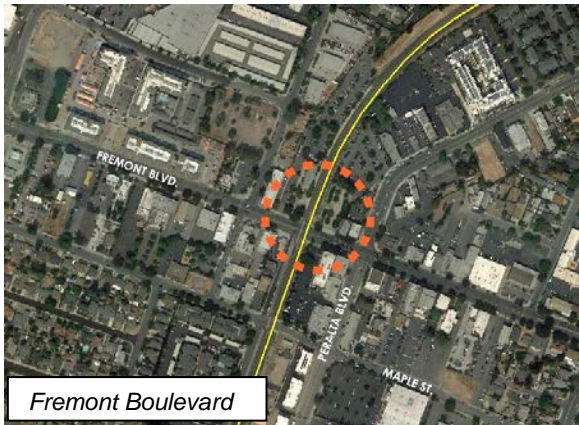
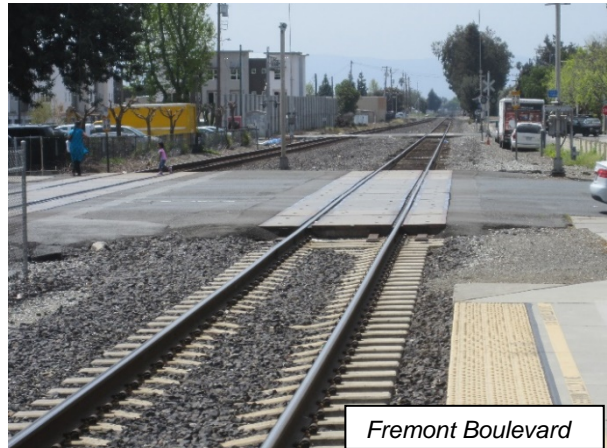
4.2.1 Fremont Boulevard

The Tier 1 Fremont Boulevard is located in the City of Fremont in the Centerville District. It is a four-lane major arterial (SR 84) that crosses the railroad at 90 degrees. The roadway crosses the tracks in a slight vertical sag curve. The speed limit for the roadway is 30 mph. Warning devices include one set of flashing lights and gates (Standard CPUC No.9s) for each direction.

Potential deficiencies noted in the site visit include:

- Long 3-minute gate down times when passenger trains are stopped at the Fremont station causes lengthy 15- to 20-vehicle queues at the crossing
- Sidewalks in crossing area are AC pavement
- No warning devices on the opposite quadrants for pedestrians in opposite direction
- No center median to prevent vehicles from driving around the gate arms

The cause of the long gate down times is that the passenger platform extends into the limits of the signal island circuit. An island circuit is similar to a traffic loop. Any time a train is within the circuit it keeps the crossing signals activated and the gates down. The traditional solution would be to shorten the island circuits to the minimum length allowable by code and place a stop short sign so the train stops before the

Recommended near-term safety enhancements include:

- Add 60- to 100-foot-long raised medians on each side of the crossing and close Peralta Court just east of the crossing
- Upgrade sidewalks in crossing area to ADA-compliant PCC
- Install “No Trespassing” signs
- Perform crossing signal study to determine best technical solution to minimize gate down time

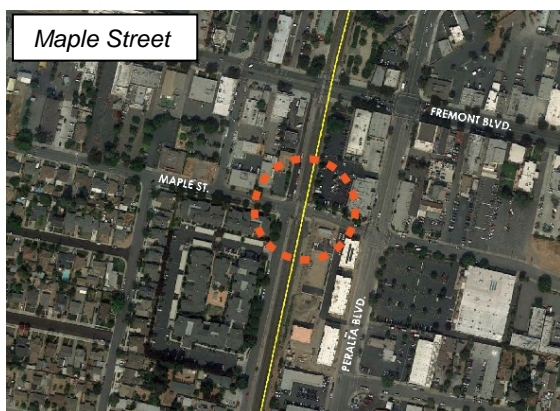
4.2.2 Maple Street

The Maple Street crossing along the Niles Subdivision, located in the City of Fremont in the Centerville District, is a two-lane roadway that crosses the railroad at 90 degrees. The roadway is slightly higher than the grade of the railroad. Sidewalks extend across the tracks and are ADA-compliant. The posted speed for the roadway is 25 mph. Warning devices include one set of flashing lights and gates (Standard CPUC No.9s) for each direction. Baine Avenue is immediately adjacent to the railroad on the west

Potential deficiencies noted in the site visit include:

- Intersection is 25 feet from the nearest track on west

Four-quadrant gates would be required should the City decide to apply for a quiet zone that includes this crossing. The crossing could also be considered for potential closure given the low volume of vehicle traffic (3,200 ADT) and close proximity of Baine Avenue to the tracks.

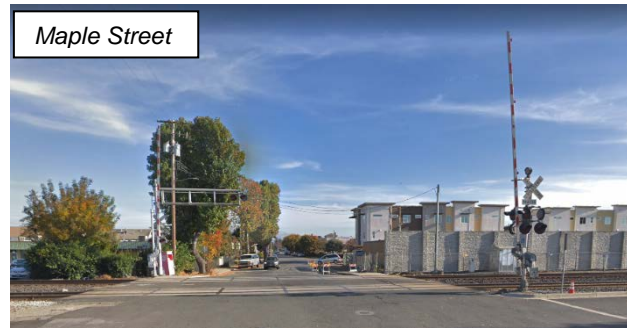
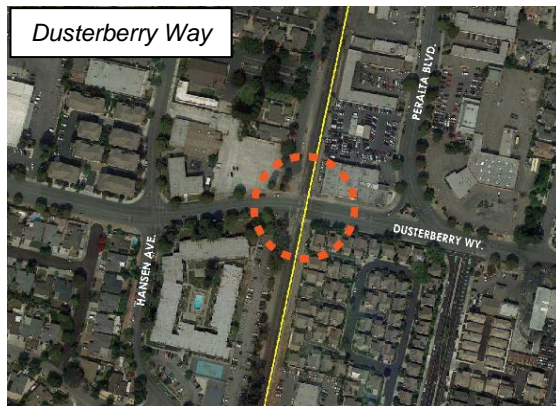
The Dusterberry Way crossing is a Tier 1 crossing located about 1,800 feet west of the Fremont Boulevard crossing on the Centerville Line. The street is a four-lane arterial that crosses the rail line at 87 degrees. The crossing has two mainline tracks and the roadway is close to the same grade as the railroad. Warning devices include two CPUC standard No.9s (flashing lights and gates), one for each roadway direction.

Recommended near-term safety enhancements include:

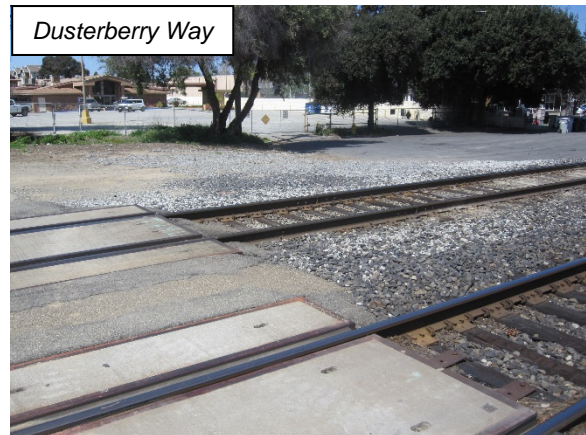
4.2.3 Dusterberry Way

Potential deficiencies noted in the site visit include:

- Concrete sidewalks on the north side of the crossing have substandard width and clearance from utility poles
- No center median to prevent vehicles from driving around the gate arms
- No warning devices on the opposite quadrants for pedestrians in opposite direction
- Right-of-way at all four quadrants open to the public for trespassing

- Widen concrete sidewalks on the north side,
- Install separate pedestrian gates on each side of street
- Add 60- to 100-foot-long raised medians on each side of the crossing
- Install partial 200-foot-long security fence (100 feet on each side of the street) and maintenance access gates to each quadrant to deter trespassing
- Install “No Trespassing” signs

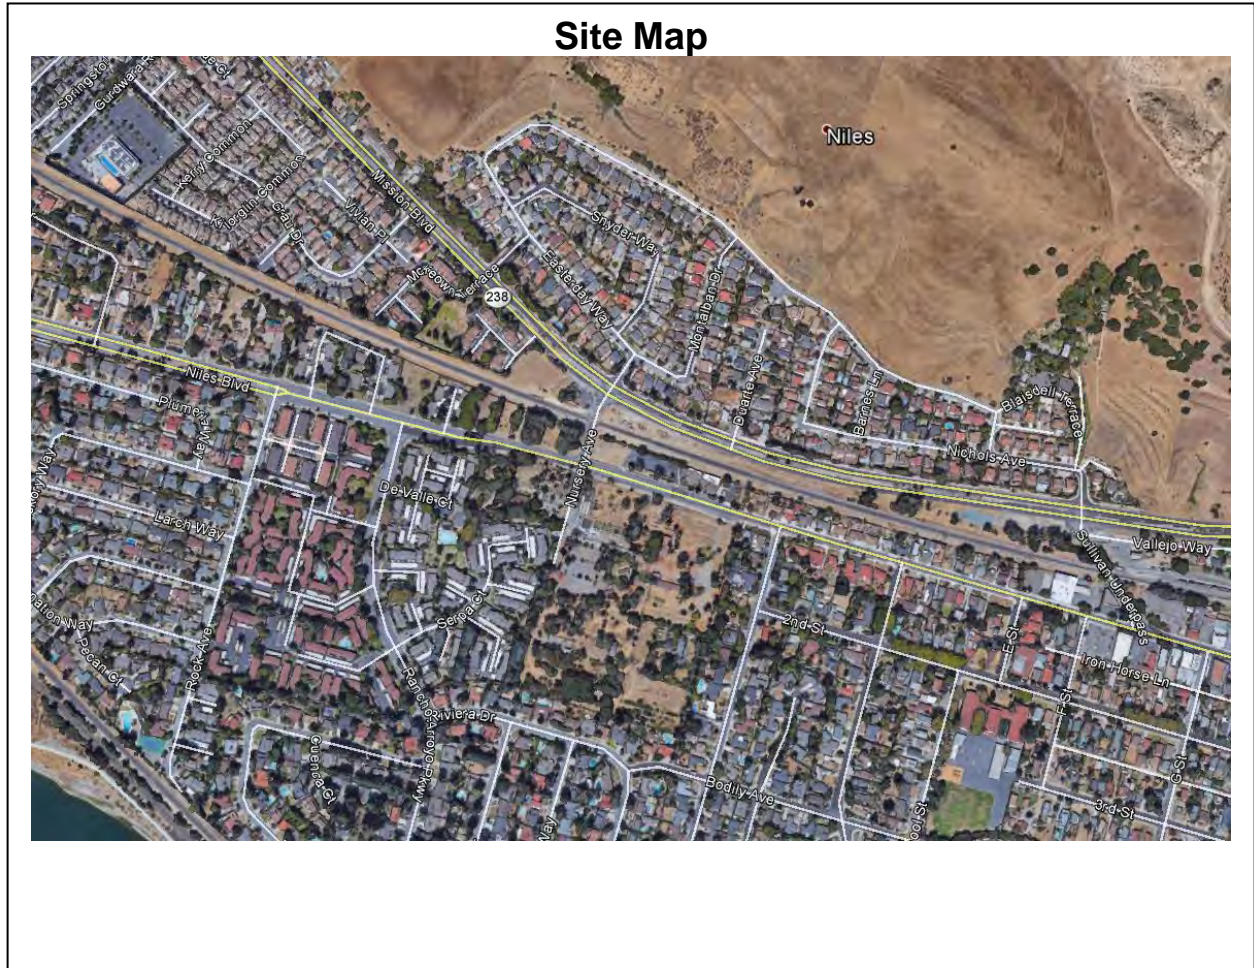
Site Map

Crossing Characteristics	Existing Condition
Track Characteristics:	Speed: 79-50 Rail Wt. <u>136</u> CWR; Joint Locations: Comp joints on either sides of crossing Crossing Surface: Concrete Panels Crossing Length: 50' Single Track General Condition: Poor
Crossing Warning Devices	Type: Flashing light warning device with crossing gates - BFG Location: Edge of pavement NW and SE. Signal house in E quadrant Condition: Up to current standards.
Roadway Characteristics	Posted Speed: 25MPH Surface: AC Width: 24' Crossing Angle: 90d Center Medians: No Curbs/Shoulders: Shoulders and sidewalks. Sidewalk not wide enough SE side, no sidewalk on NW side
Adjacent Intersections	Commercial Driveway – 50' NW Mission Blvd Inters – 110' NW Miles Blvd Inters – 160' S
Existing Utilities	In Roadway: OH crossing (elec and comm) NW side, Riser pole in west quadrant Along RR: PGE gas line (x2) N side of crossing, FOC N and S sides. Comm substation (NW quadrant),

Comments	<ul style="list-style-type: none"> • Semi trailer trucks drive along N side of ROW, entering from NW quadrant • Very busy crossing • Ped crossing not present on NW side. Ped crossing on SE side not wide enough. • Roadway in poor condition: raveling and potholes present. • Grade crossing striping in poor shape. • ROW not fenced • No “No Trespassing” signs present.
----------	--

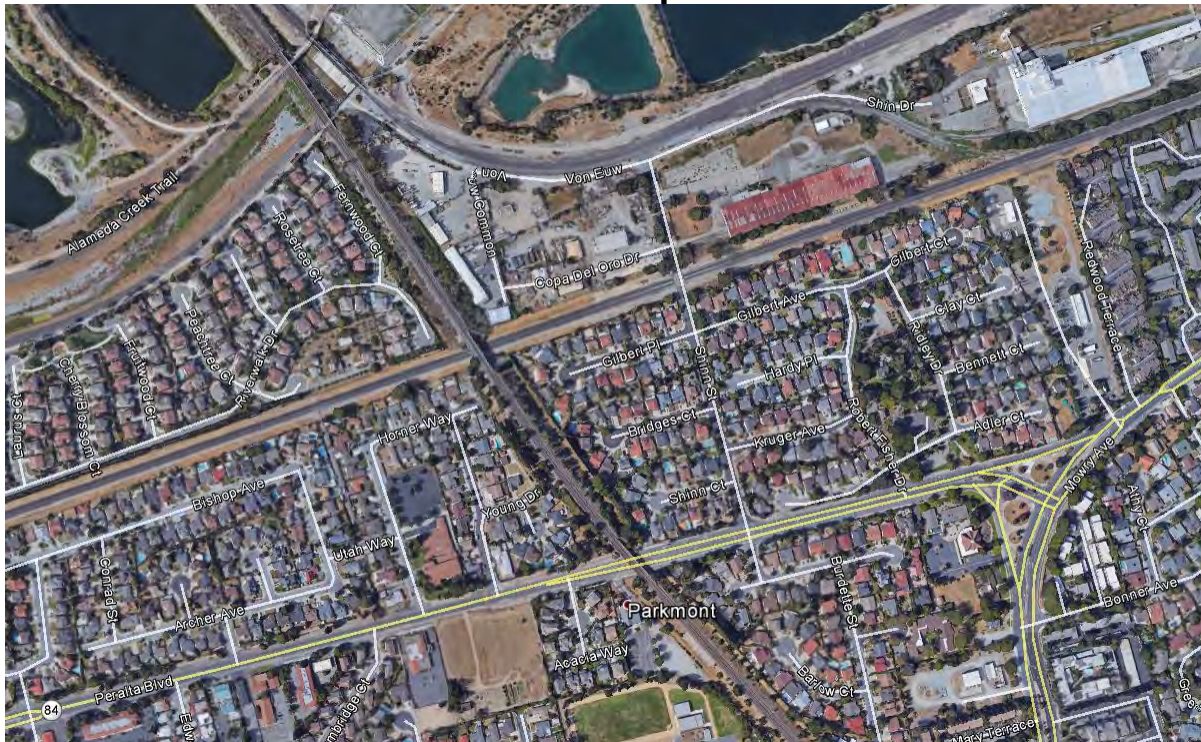
Site Map

Crossing Characteristics	Existing Condition
Track Characteristics:	Speed: 79-50 Rail Wt. <u>136</u> CWR; Joint Locations: Comp joints on either sides of crossing Crossing Surface: Concrete Panels Crossing Length: 40' Double Track General Condition: Good
Crossing Warning Devices	Type: Flashing light warning device with crossing gates - BFG Location: Off edge of pavement (NE and SW quadrants) Signal house in NE quadrant Condition: Up to current standards.
Roadway Characteristics	Posted Speed: 25MPH Surface: AC Width: 36' Crossing Angle: 86d Center Medians: No Curbs/Shoulders: Sidewalks end at ROW and peds and bikes are forced into roadway to cross
Adjacent Intersections	Commercial Driveway – 125' NW Von Euw Inters – 450' NW Gilbert Ave Inters – 190' SW
Existing Utilities	In Roadway: OH Crossing (Elec and Comm) Along RR: FOC, Elec meter pedestal (NE), vault (NE)
Geometric Issues/Constraints	
Pedestrian Activity	Yes

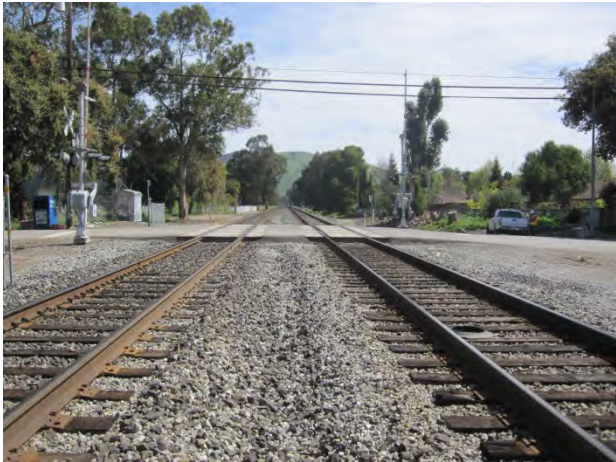
RR Looking North East

Comments	<ul style="list-style-type: none"> • ROW gates present at NE and NW quadrants. No gates or fences at SW and SE quadrants • No “No Trespassing” Signs present any quadrant • ROW fence along NW side in poor shape
----------	--

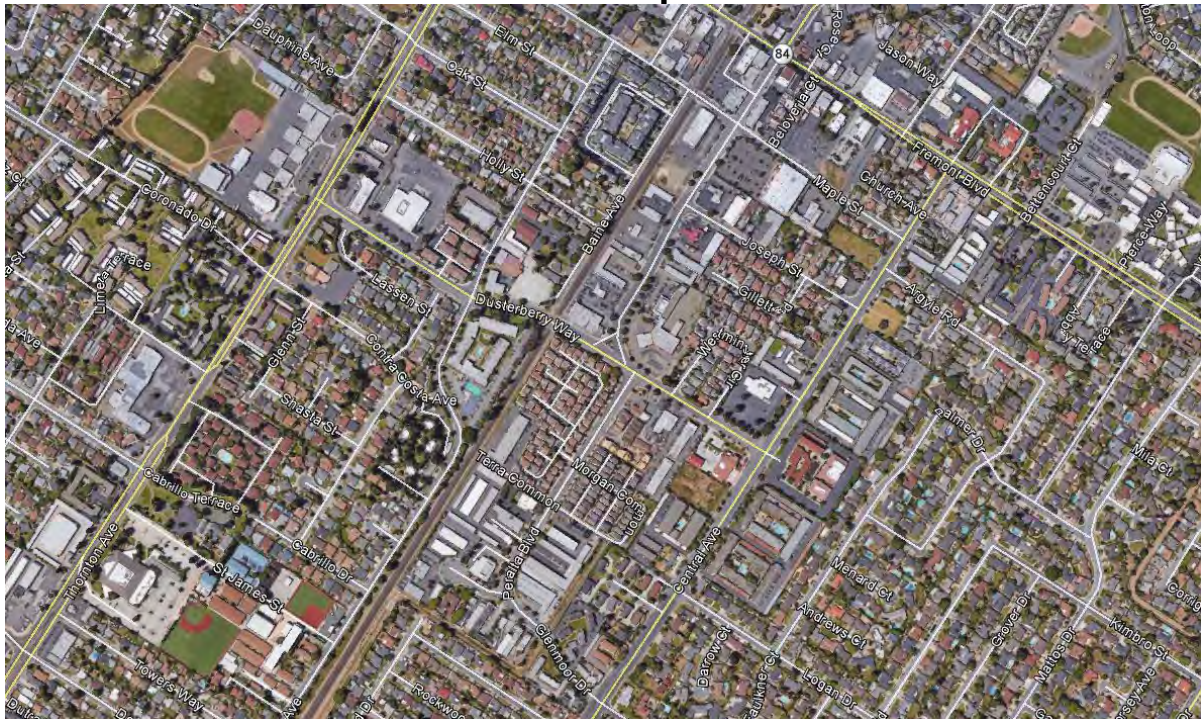
Site Map

Crossing Characteristics	Existing Condition
Track Characteristics:	Speed: 79-50 Rail Wt. <u>136</u> CWR; Joint Locations: Comp joints on either sides of crossing Crossing Surface: Concrete Panels Crossing Length: 90' Double Track General Condition: Good
Crossing Warning Devices	Type: Flashing light warning device with crossing gates - BFG Location: East in SW, West at back of curb. Signal house in S quadrant Condition: Up to current standards.
Roadway Characteristics	Posted Speed: 35MPH Surface: AC Width: 64' Crossing Angle: 87d Center Medians: No Curbs/Shoulders: Sidewalk is not wide enough, poles impede access along E side
Adjacent Intersections	Commercial Driveway – 63'SE Peralta Blvd Inters – 340'SE Commercial Driveway – 85'NW Hansen Ave Inters – 420'NW
Existing Utilities	In Roadway: SD MH, ATT vault, PGE vault, street lights, OH poles Along RR: FOC (SE), open trench (SE), OH poles Elec and Comm (SE)

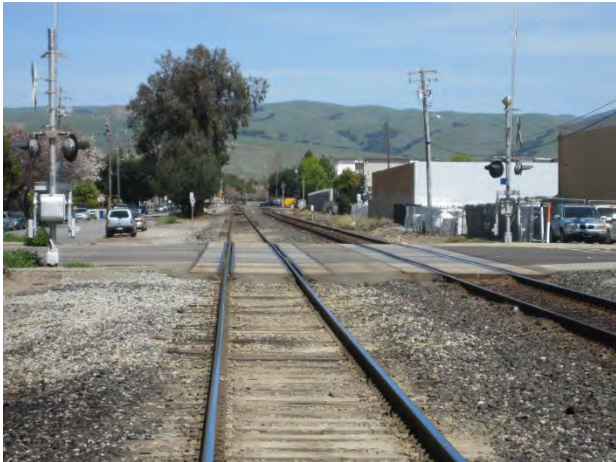
RR Looking North East

Comments	<ul style="list-style-type: none">• Right of way at quadrants not protected by gates or fence.• Not adequate space for pedestrians to pass behind signals on sidewalk.•
----------	---

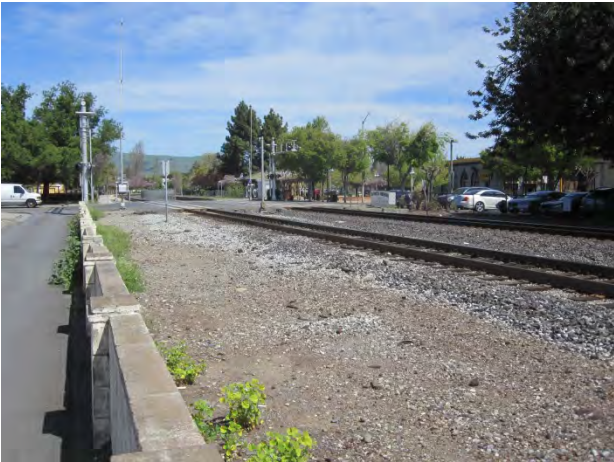
RR Looking North East

Crossing Characteristics	Existing Condition
Track Characteristics:	Speed: 79-45 Rail Wt. <u>136</u> CWR; Joint Locations: Comp joints on either sides of crossing Crossing Surface: Concrete Panels Crossing Length: 100' Double Track General Condition: Good
Crossing Warning Devices	Type: Flashing light warning device with crossing gates and cantilevers- BFG Location: East side in SW, W side off edge of pavement. Signal house in E quadrant Condition: Up to current standards.
Roadway Characteristics	Posted Speed: 30MPH Surface: AC Width: 60' Crossing Angle: 90d Center Medians: No Curbs/Shoulders: Sidewalks. Reduced clearance at back of signal on E quadrant. SW ends at ROW and turns to AC.
Adjacent Intersections	Commercial Driveway – 100'NW Alley – 20'NW Bonde Way Inters – 215' NW Commercial Driveway – 40'SE Peralta Blvd Inters – 225'SE
Existing Utilities	In Roadway: Streetlights, Water meter, Fire Hydrants, PGE Vault, Comm Vault, Inlets Along RR: SD MH, PGE gas crossing SW side,

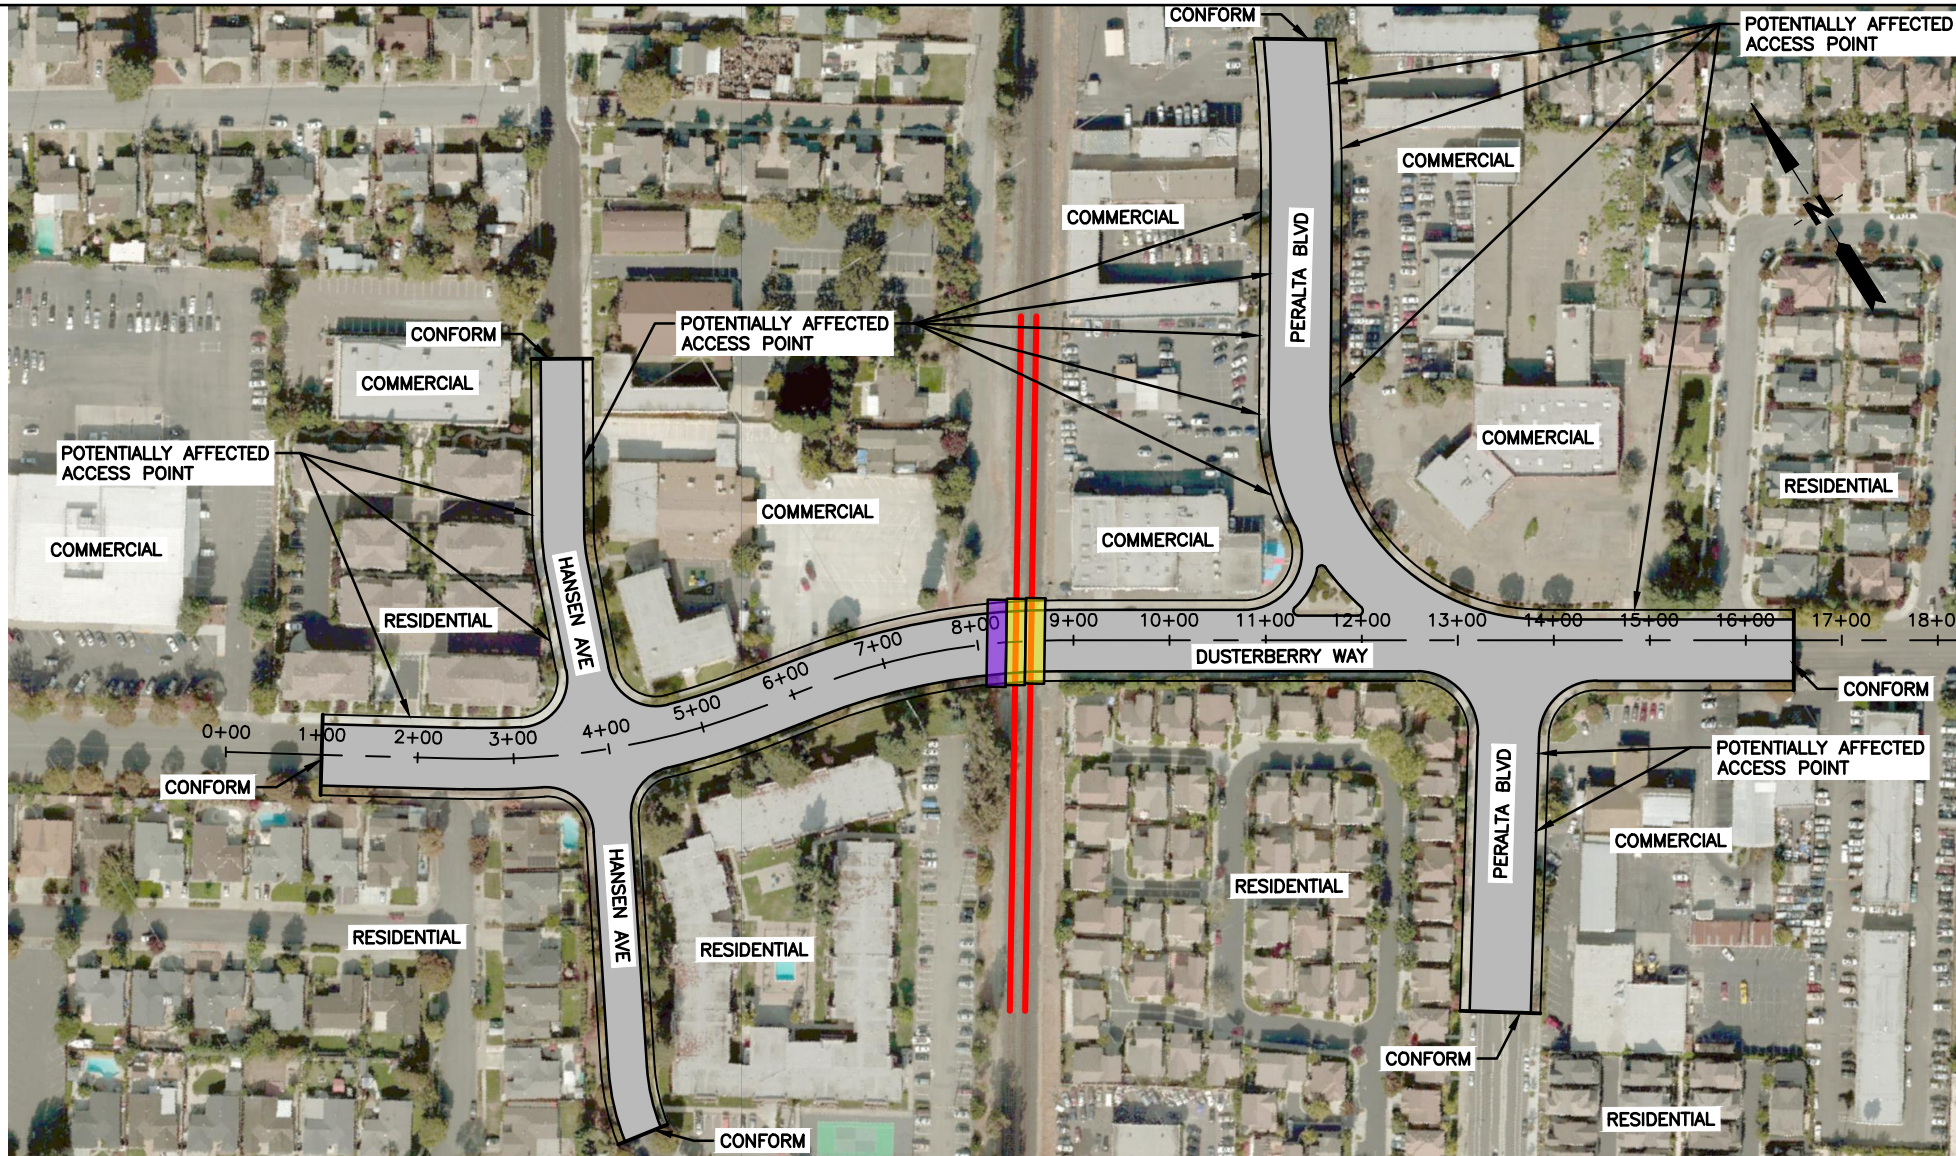
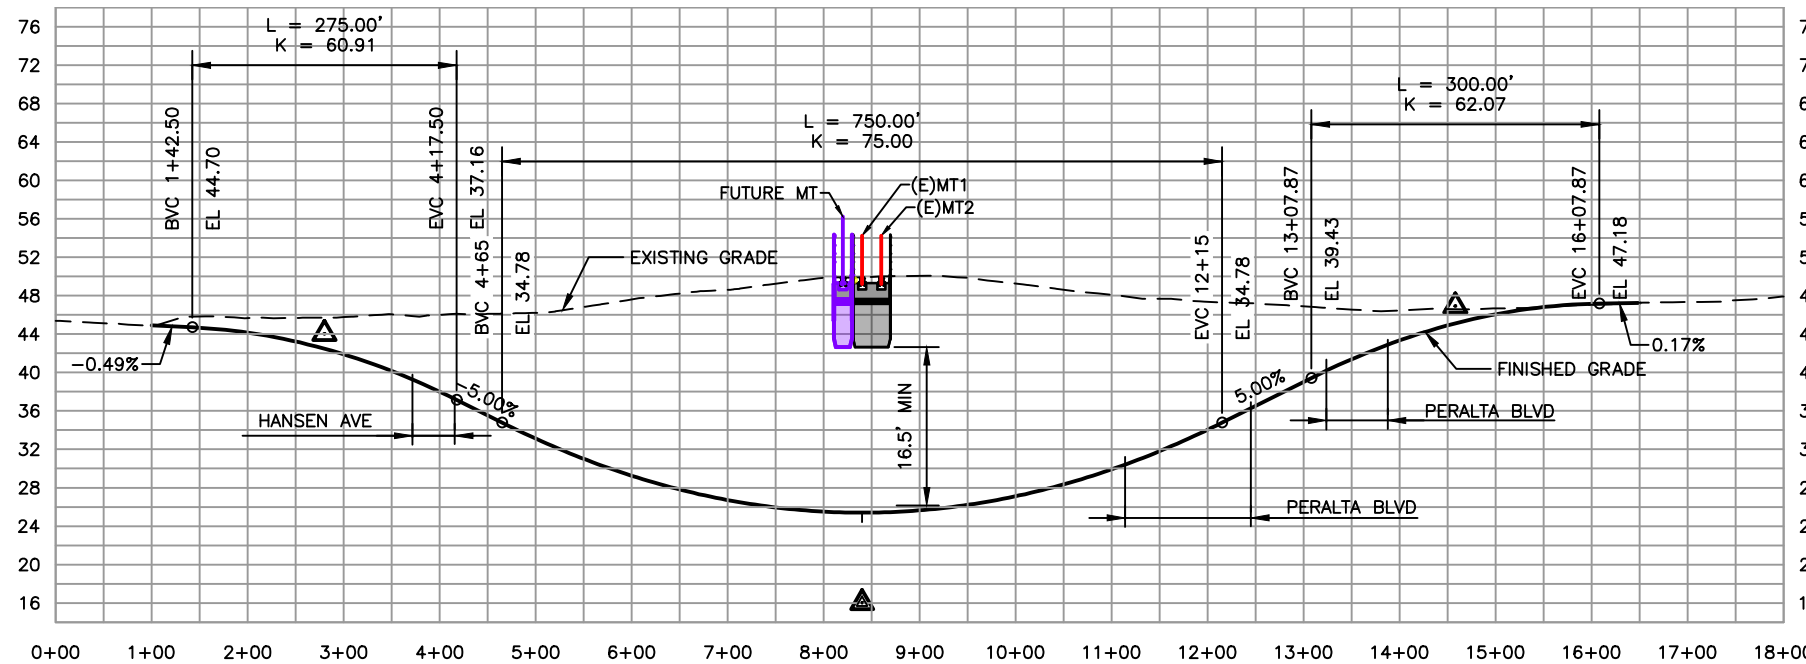
DUSTERBERRY WAY PROFILE

Grade Separation “Initial Scan”: As a Tier 1 crossing, Dusterberry Way is a potential candidate for a grade separation. Based on site observations, a 70-foot-long roadway underpass (70-foot-long long railroad structure over the roadway) would likely be required at this location. However, due to the crossing’s proximity to Peralta Boulevard and Hansen Avenue, those intersections would have to be lowered approximately 5 feet to create enough depth for Dusterberry Way to clear the railroad. Access to business in the northeast quadrant would be eliminated. Based on experience with similar sites, the preferred railroad superstructure would likely consist of a one-span 70-foot-long rolled steel beam deck bridge with a steel ballast pan to bring the superstructure depth down to 5 feet from top of rail. For foundations, the abutments would need to be supported by large diameter CIDH or CISS piles, concrete columns, and precast concrete caps. The roadway profile would need to be depressed approximately 25 feet below the surrounding ground. A pump station would be required to pump stormwater out of the roadway portion of the underpass. The roadway profile conform points are approximately 750 feet on either side of the crossing assuming that the Peralta and Hansen intersections are lowered.

The Dusterberry Way crossing would likely be categorized as a lower priority grade separation due to its relatively low daily traffic counts relative to other Tier 1 crossings. **Appendix B** includes an exhibit of the conceptual grade separation, as well as profile and typical section at Dusterberry Way.

Based on the conceptual grade separation design described in Section 4.2 and shown in **Appendix B**, the Capex cost for the Dusterberry Way grade separation is \$86.4 million. This cost is summarized in Table 8. Additional analysis is required to prioritize the grade separations based on the benefits derived versus the cost of the project.
