Alameda CTC – RSEP

Berkeley IS/MND

WATER QUALITY AND DRAINAGE MEMO
MAY 14, 2021 | DRAFT

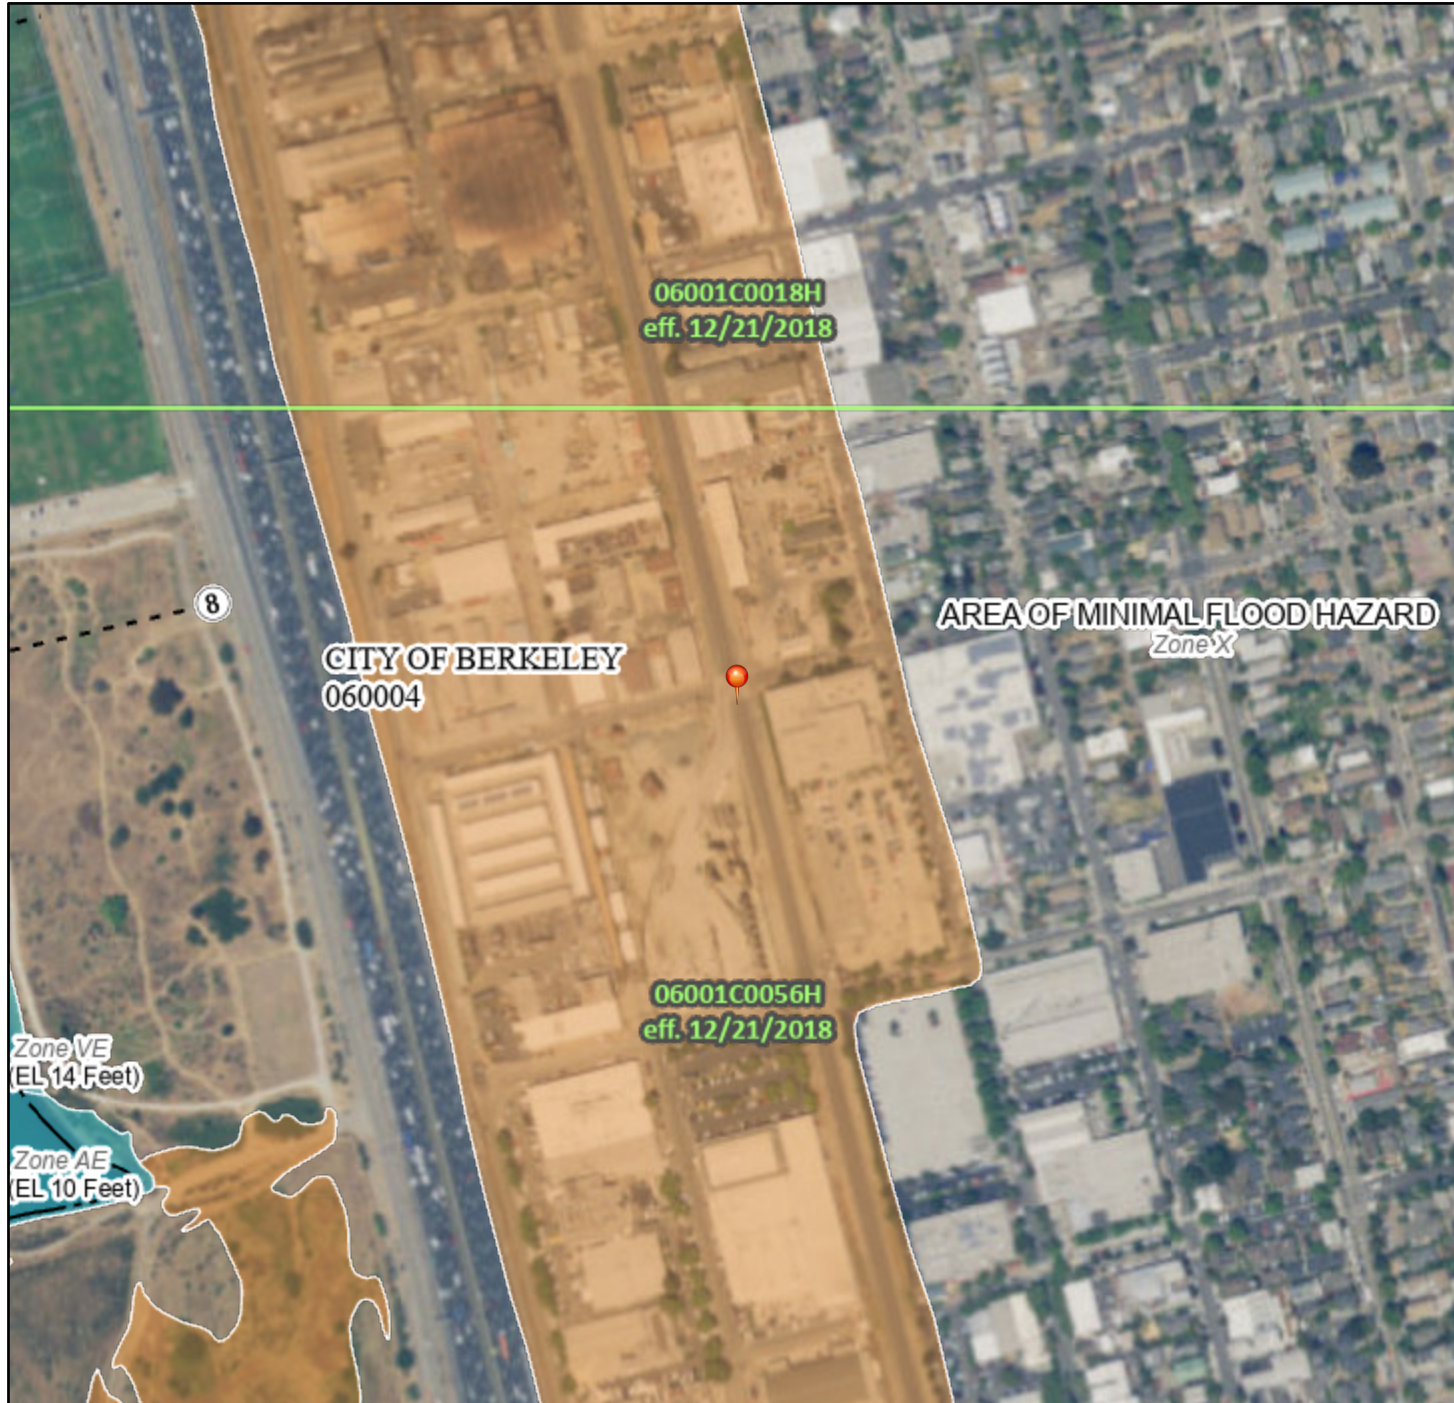
National Flood Hazard Layer FIRMMette

SPECIAL FLOOD HAZARD AREAS		Without Base Flood Elevation (BFE) <i>Zone A, V, A99</i>
		With BFE or Depth <i>Zone AE, AO, AH, VE, AR</i>
		Regulatory Floodway

OTHER AREAS OF FLOOD HAZARD		0.2% Annual Chance Flood Hazard, Areas of 1% annual chance flood with average depth less than one foot or with drainage areas of less than one square mile <i>Zone X</i>
		Future Conditions 1% Annual Chance Flood Hazard <i>Zone X</i>
		Area with Reduced Flood Risk due to Levee. See Notes. <i>Zone X</i>
		Area with Flood Risk due to Levee <i>Zone D</i>

OTHER AREAS		NO SCREEN Area of Minimal Flood Hazard <i>Zone X</i>
		Effective LOMRs
		Area of Undetermined Flood Hazard <i>Zone D</i>
GENERAL STRUCTURES		Channel, Culvert, or Storm Sewer
		Levee, Dike, or Floodwall

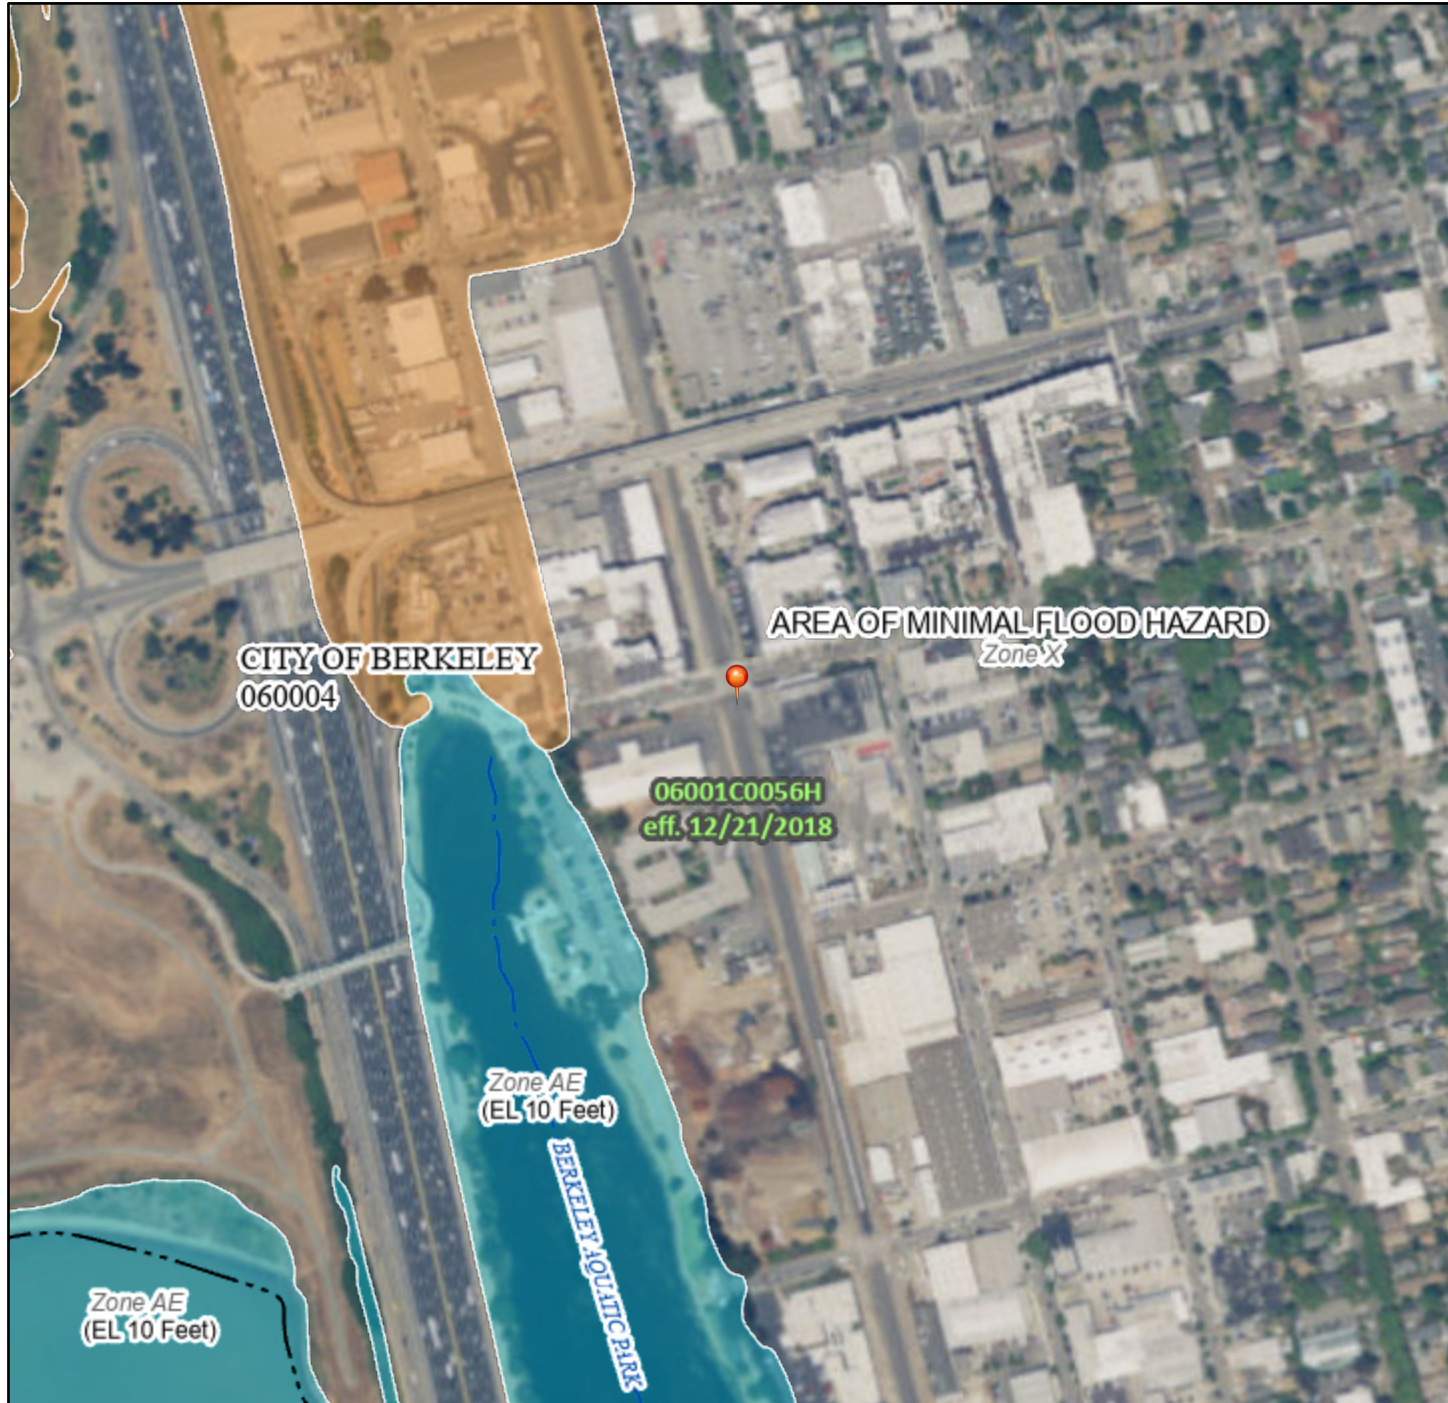
National Flood Hazard Layer FIRMette

SPECIAL FLOOD HAZARD AREAS		Without Base Flood Elevation (BFE) <i>Zone A, V, A99</i>
		With BFE or Depth <i>Zone AE, AO, AH, VE, AR</i>
		Regulatory Floodway
OTHER AREAS OF FLOOD HAZARD		0.2% Annual Chance Flood Hazard, Areas of 1% annual chance flood with average depth less than one foot or with drainage areas of less than one square mile <i>Zone X</i>
		Future Conditions 1% Annual Chance Flood Hazard <i>Zone X</i>
		Area with Reduced Flood Risk due to Levee. See Notes. <i>Zone X</i>
		Area with Flood Risk due to Levee <i>Zone D</i>
OTHER AREAS		NO SCREEN Area of Minimal Flood Hazard <i>Zone X</i>
		Effective LOMRs
GENERAL STRUCTURES		Area of Undetermined Flood Hazard <i>Zone D</i>
		Channel, Culvert, or Storm Sewer
		Levee, Dike, or Floodwall
OTHER FEATURES		20.2 Cross Sections with 1% Annual Chance Water Surface Elevation

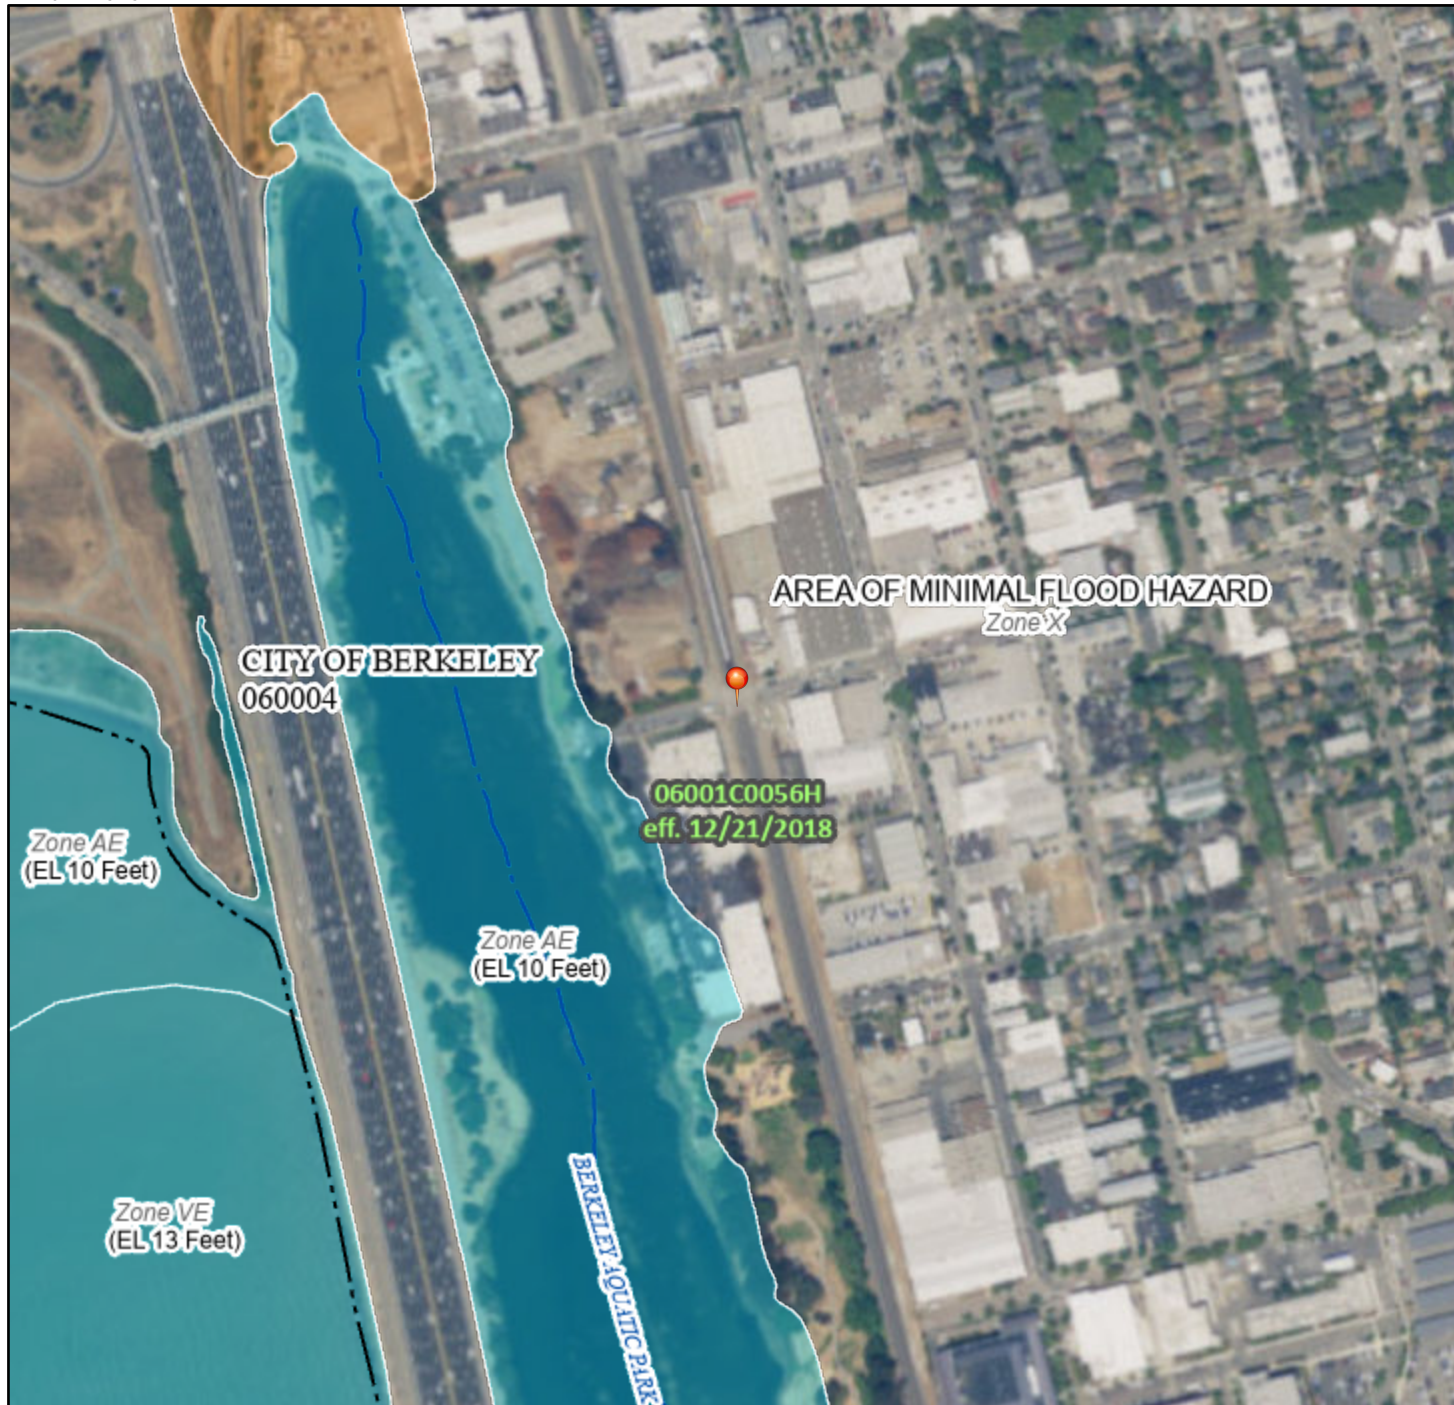
National Flood Hazard Layer FIRMette

SPECIAL FLOOD HAZARD AREAS		Without Base Flood Elevation (BFE) <i>Zone A, V, A99</i>
		With BFE or Depth <i>Zone AE, AO, AH, VE, AR</i>
		Regulatory Floodway
OTHER AREAS OF FLOOD HAZARD		0.2% Annual Chance Flood Hazard, Areas of 1% annual chance flood with average depth less than one foot or with drainage areas of less than one square mile <i>Zone X</i>
		Future Conditions 1% Annual Chance Flood Hazard <i>Zone X</i>
		Area with Reduced Flood Risk due to Levee. See Notes. <i>Zone X</i>
		Area with Flood Risk due to Levee <i>Zone D</i>
OTHER AREAS		NO SCREEN Area of Minimal Flood Hazard <i>Zone X</i>
		Effective LOMRs
GENERAL STRUCTURES		Area of Undetermined Flood Hazard <i>Zone D</i>
		Channel, Culvert, or Storm Sewer
		Levee, Dike, or Floodwall
OTHER FEATURES		20.2 Cross Sections with 1% Annual Chance Water Surface Elevation

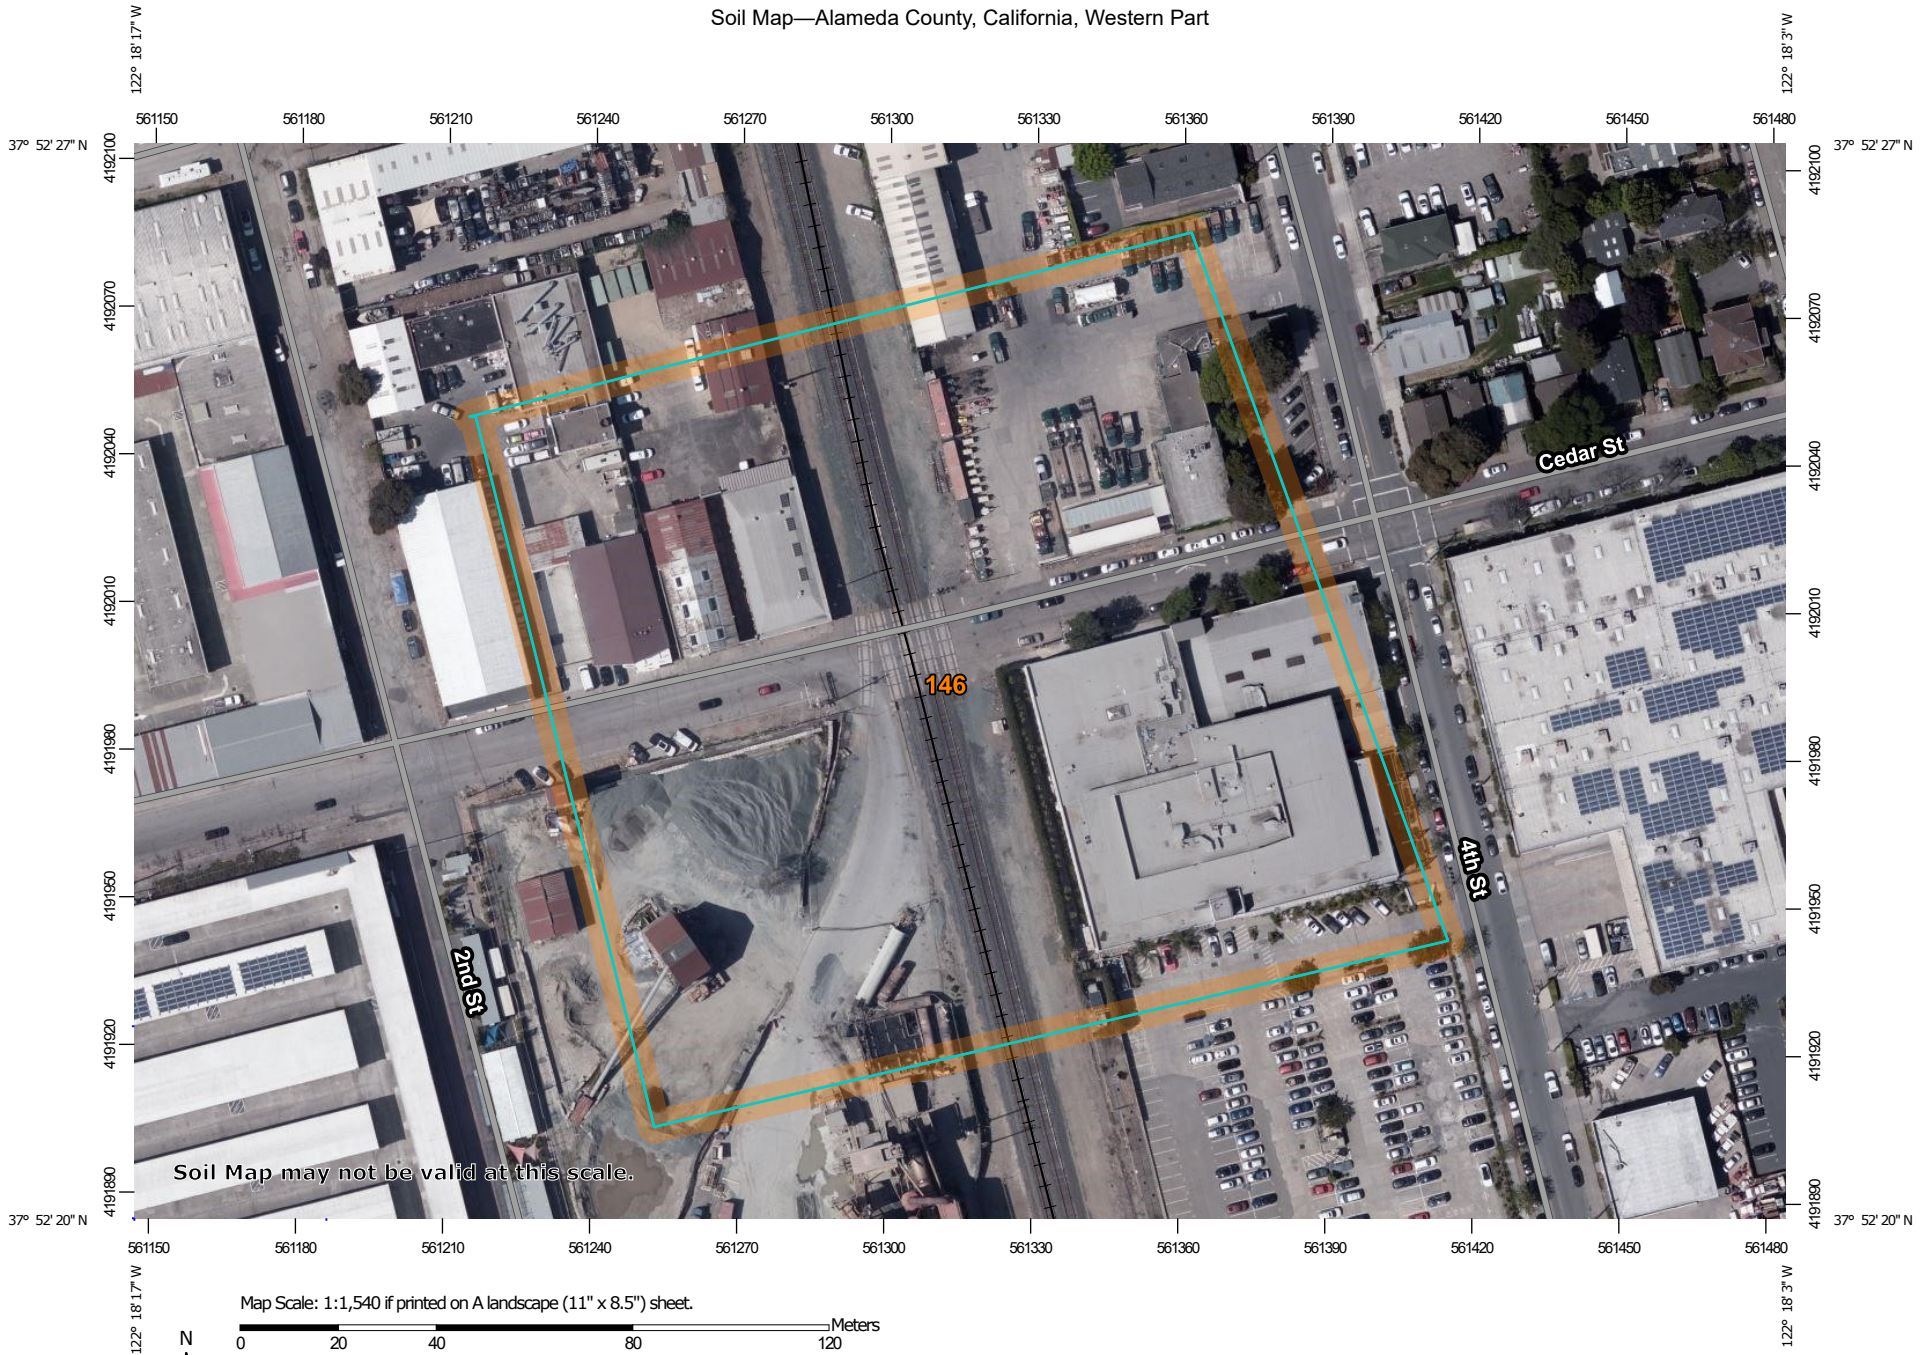
Soil Map—Alameda County, California, Western Part

Map Unit Symbol	Map Unit Name	Acres in AOI	Percent of AOI
146	Urban land	5.9	100.0%
Totals for Area of Interest		5.9	100.0%

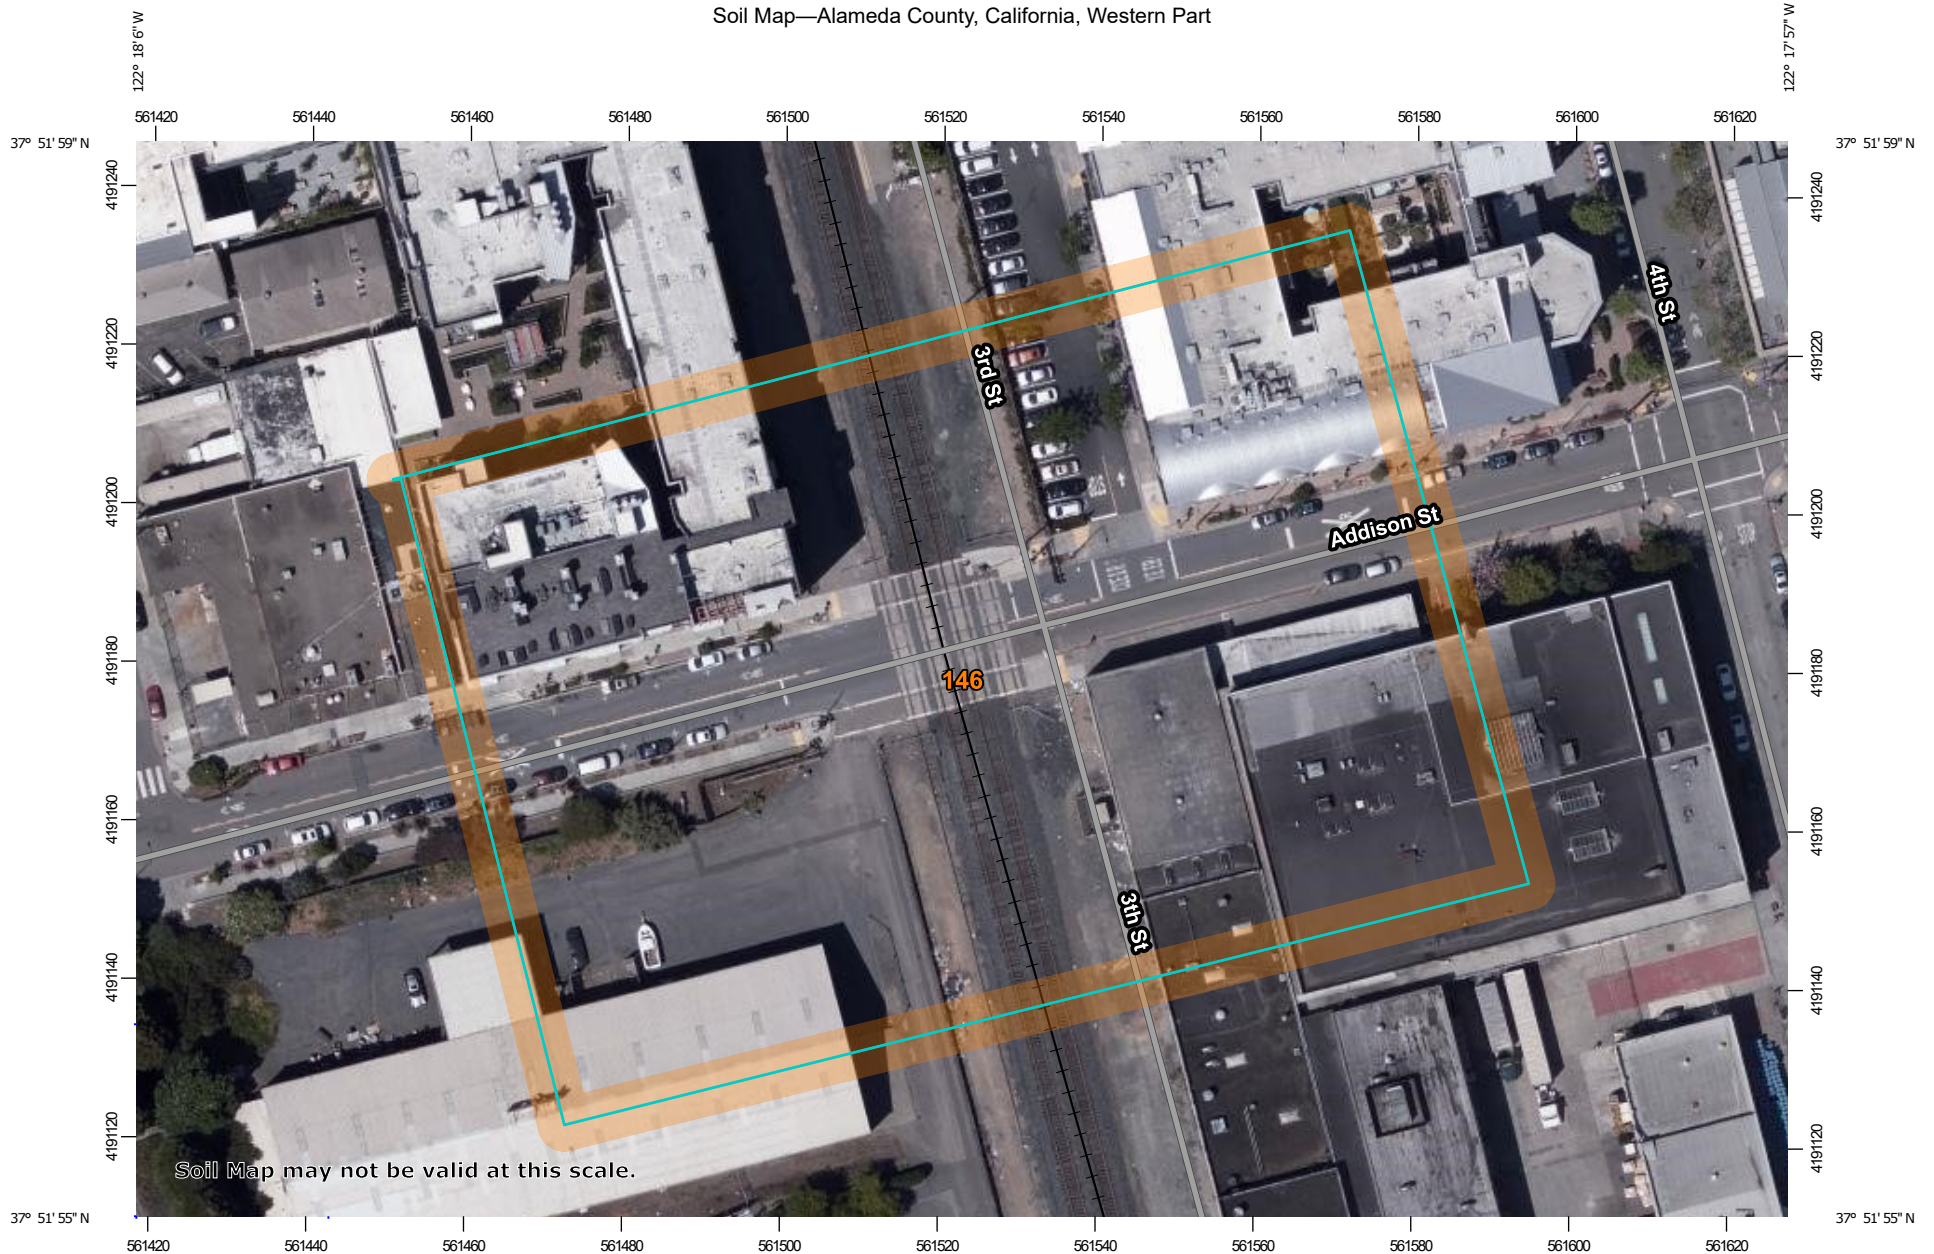
Soil Map—Alameda County, California, Western Part

Map Unit Symbol	Map Unit Name	Acres in AOI	Percent of AOI
146	Urban land	2.6	100.0%
Totals for Area of Interest		2.6	100.0%
